REPAIR OF DWPF CONTAMINATED VESSEL

- Authors:
 - J. T. Gee (Engineering)
 - J. R. Neuville (Engineering)
- SRS ALARA Workshop
- May, 2005

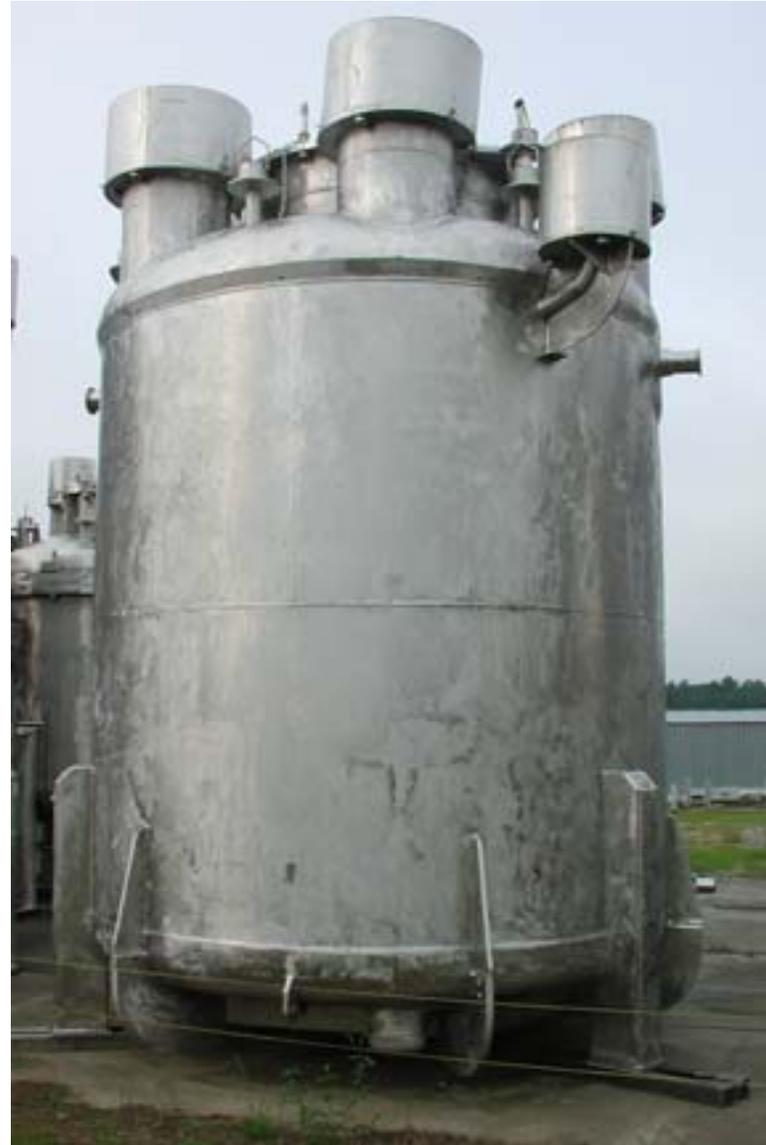
SLURRY MIX EVAPORATOR

- Placed in Radioactive Service in 1996
 - Radioactive Sludge / Glass Frit Slurry
- Tank Repaired in 2003
 - Hole in Bottom of Tank (Near Center, ~1" by 1/4")
 - Thinning Near Coil Guides
- Description (C-276 alloy)
 - Size (12' dia. x 17' high)
 - Volume (9,500 gallons)
 - Weight (45,000 lbs.)
 - Bottom Wall (3/4" thick)

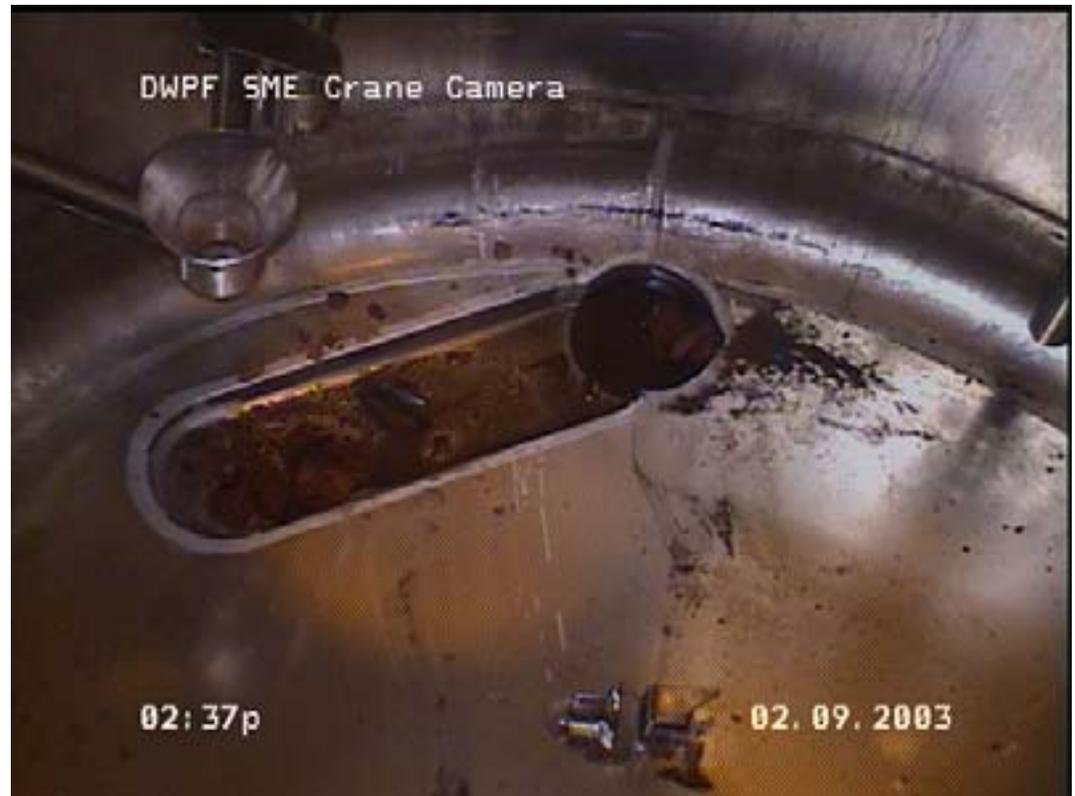
SHIELDING CONSIDERATIONS

- Shielding Strategy
 - Lead Shielding Around Sump
 - Seal Hole / Add 2' of Water
- Hot Spots (before & after shielding)
 - Tank Sump
(10-50 Rem/hr. to 2 Rem/hr.)
 - Inner Tank Wall
(2 Rem/hr)
- Work Area Under Tank
 - Dose Rate
(100-500 mrem/hr.)
