# *Hanford In-Service Inspections*

Jason Engeman

Washington River  
Protection Solutions

8/25/2009

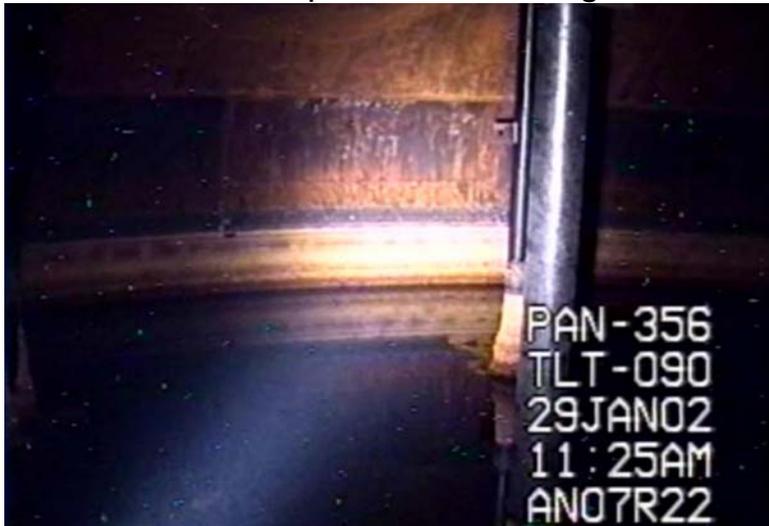
241-AN-107 Primary Tank Wall

2002 Video Inspection Wide-Angle View

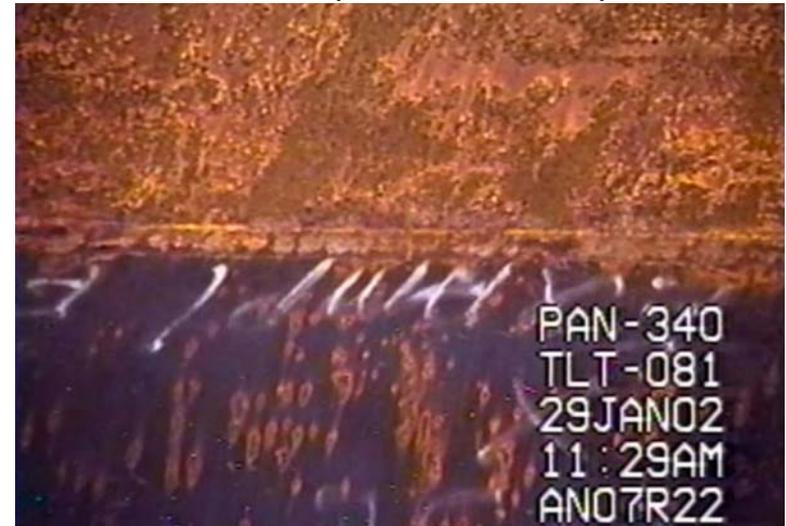
241-AN-107 Primary Tank Wall

2002 Video Inspection Close-Up View

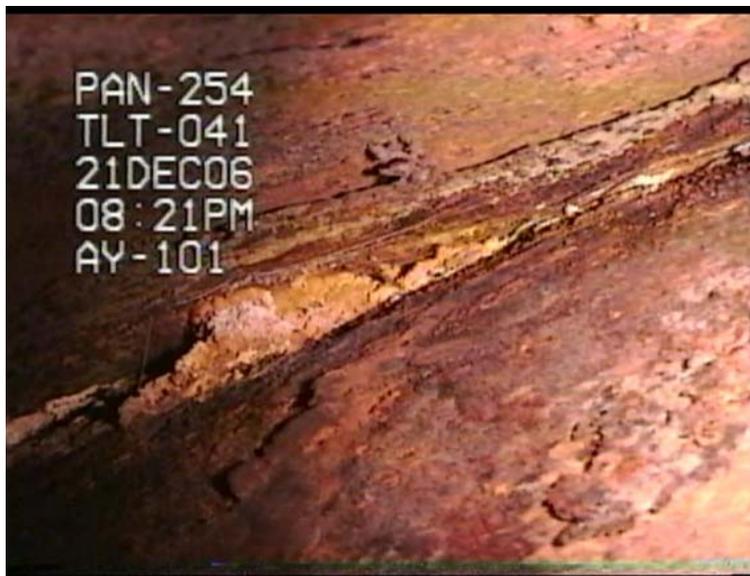
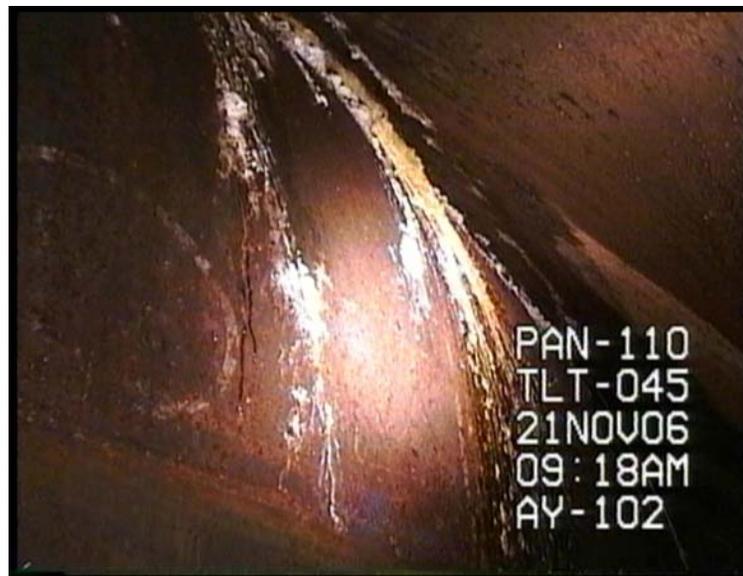
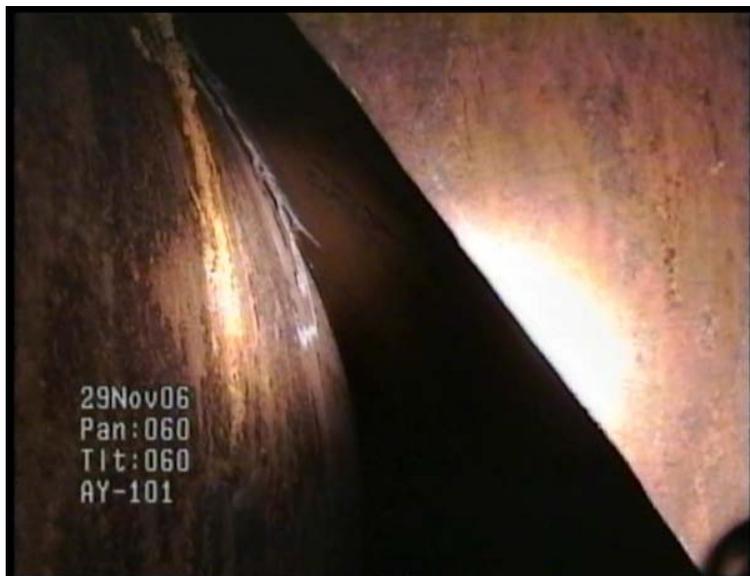
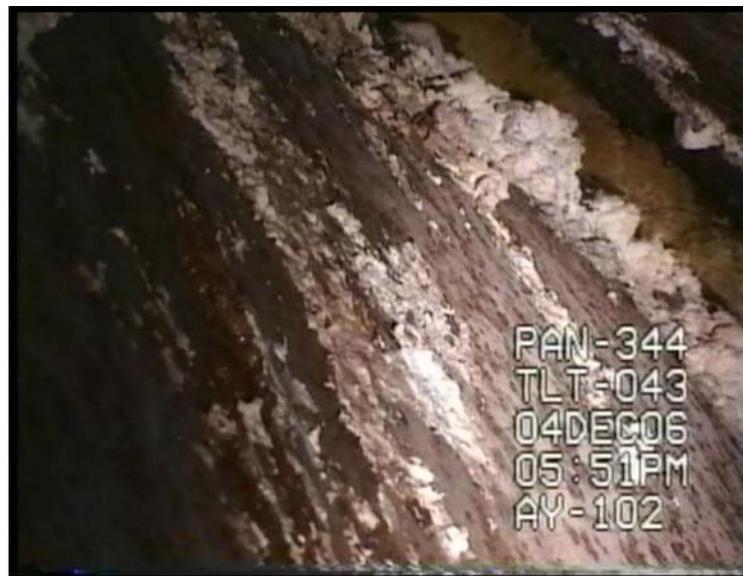
# Annulus Water Intrusion

- Most DST annuli display relatively very light corrosion (Exception: The 241-AY DSTs were subject to heavy corrosion ~10 years ago due to water intrusion into the annulus).
    - Mill scale still present in various tanks.
    - No tanks show signs of active water intrusion into the annulus.

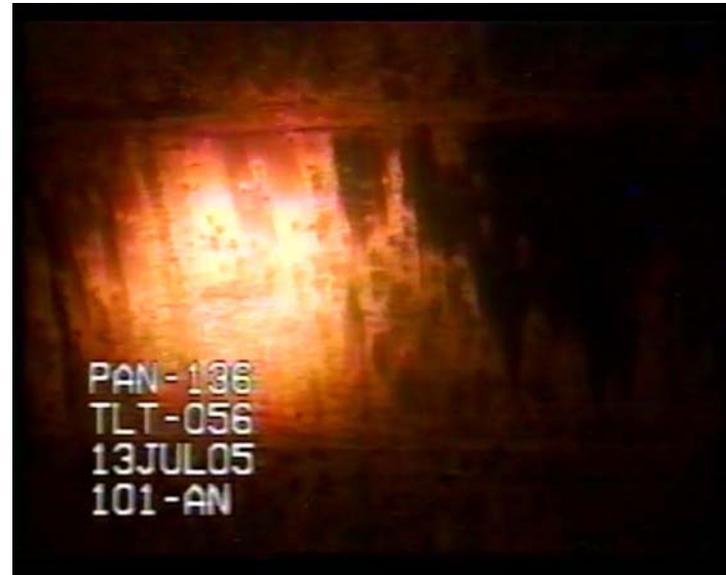
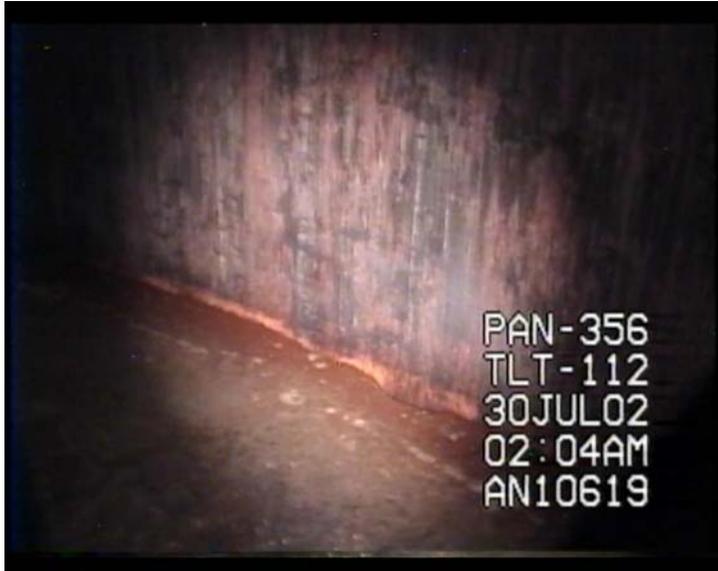
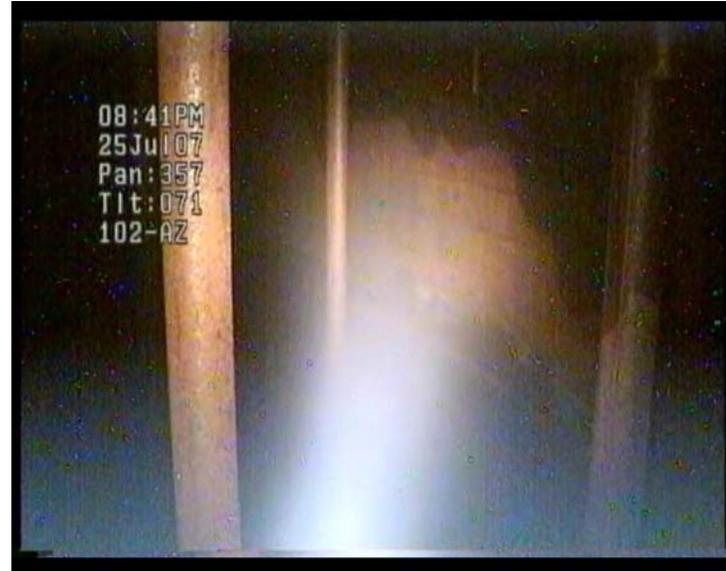
# DST Inspection Lighting Effects

- Visual Inspections Challenges
  - Inadequate Primary Inspection Lighting
    - Reduces the effective zoom capability of the inspection camera.
    - Substituting “spot light” style lighting to achieve greater viewable distances creates shadows. This makes the determination and classification of anomalies substantially more difficult as well as limiting the overall viewable region due to the focal point of the light.
  - Limited Camera Resolution
    - Currently utilized 10X/4X optical/digital zoom is insufficient for inspections requiring more than general condition monitoring at 30+ feet from area of interest.

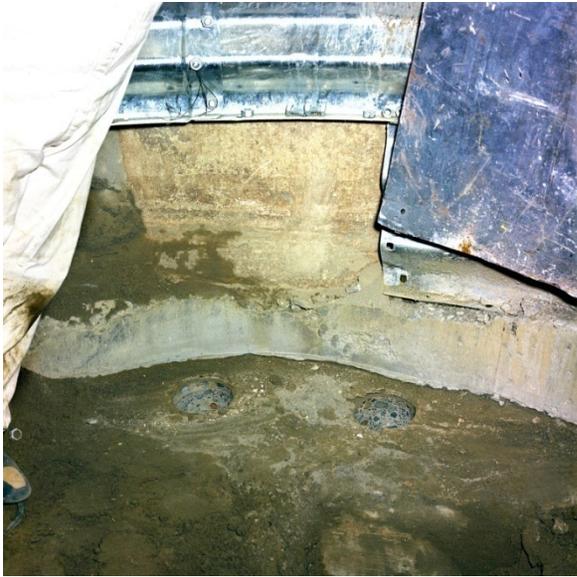
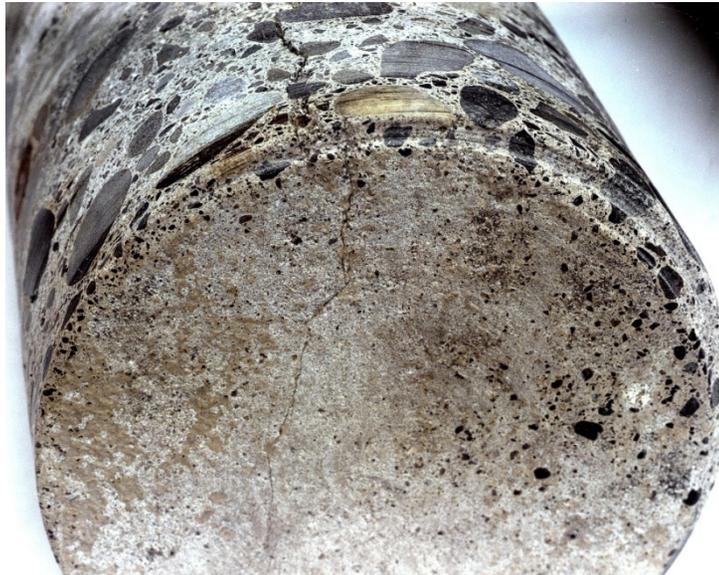
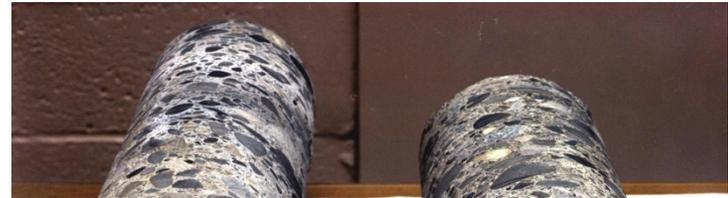
- 241-SX-108, retrieved two core samples from the tank foundation.
  - Found very little cracking.
  - Core samples found aggregate to be well distributed through the concrete.
- 241-SX-115
  - 2-Inch thick vertical core of entire SST sidewall was taken.
  - Test results showed concrete was greater than the required 28 day minimum compressive strength.
