HDB8 Jumper Repair

299H

- Repair a critical HDB8 waste transfer jumper at the 299H Decon and Maintenance Facility
-

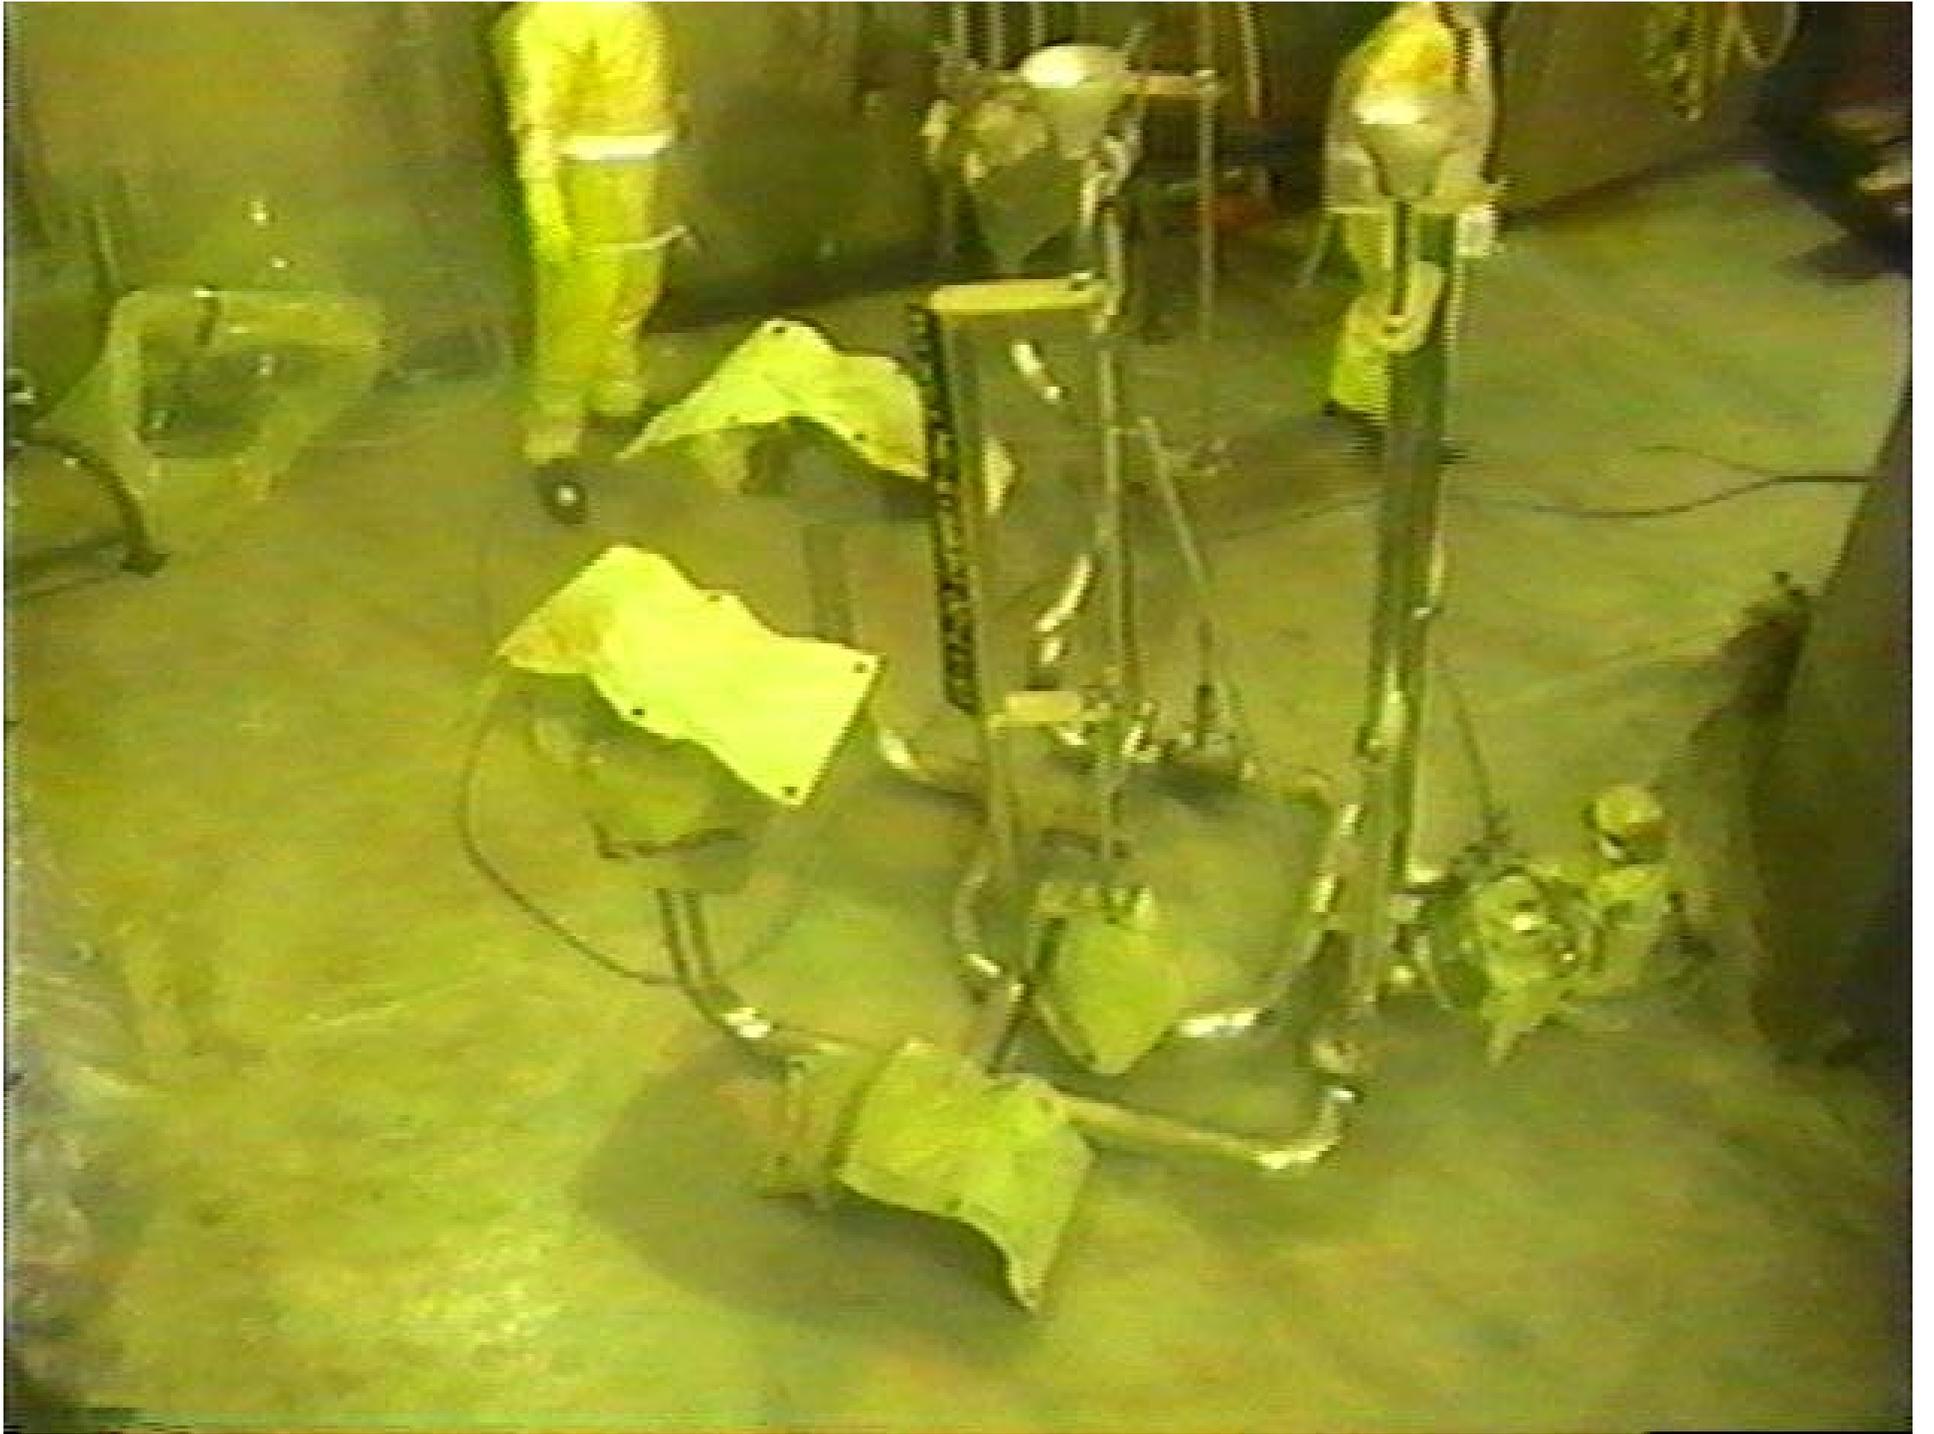
Existing Jumper Condition

- (1) of the (4) valves was no longer operable - it had been difficult to operate for several years
 - The valve operator extension handle was damaged at (1) of the universal joints
 - Radioactive waste had been transferred through the jumper for approximately (10) years – the Jumper was flushed with flushwater prior to removal for repair
-

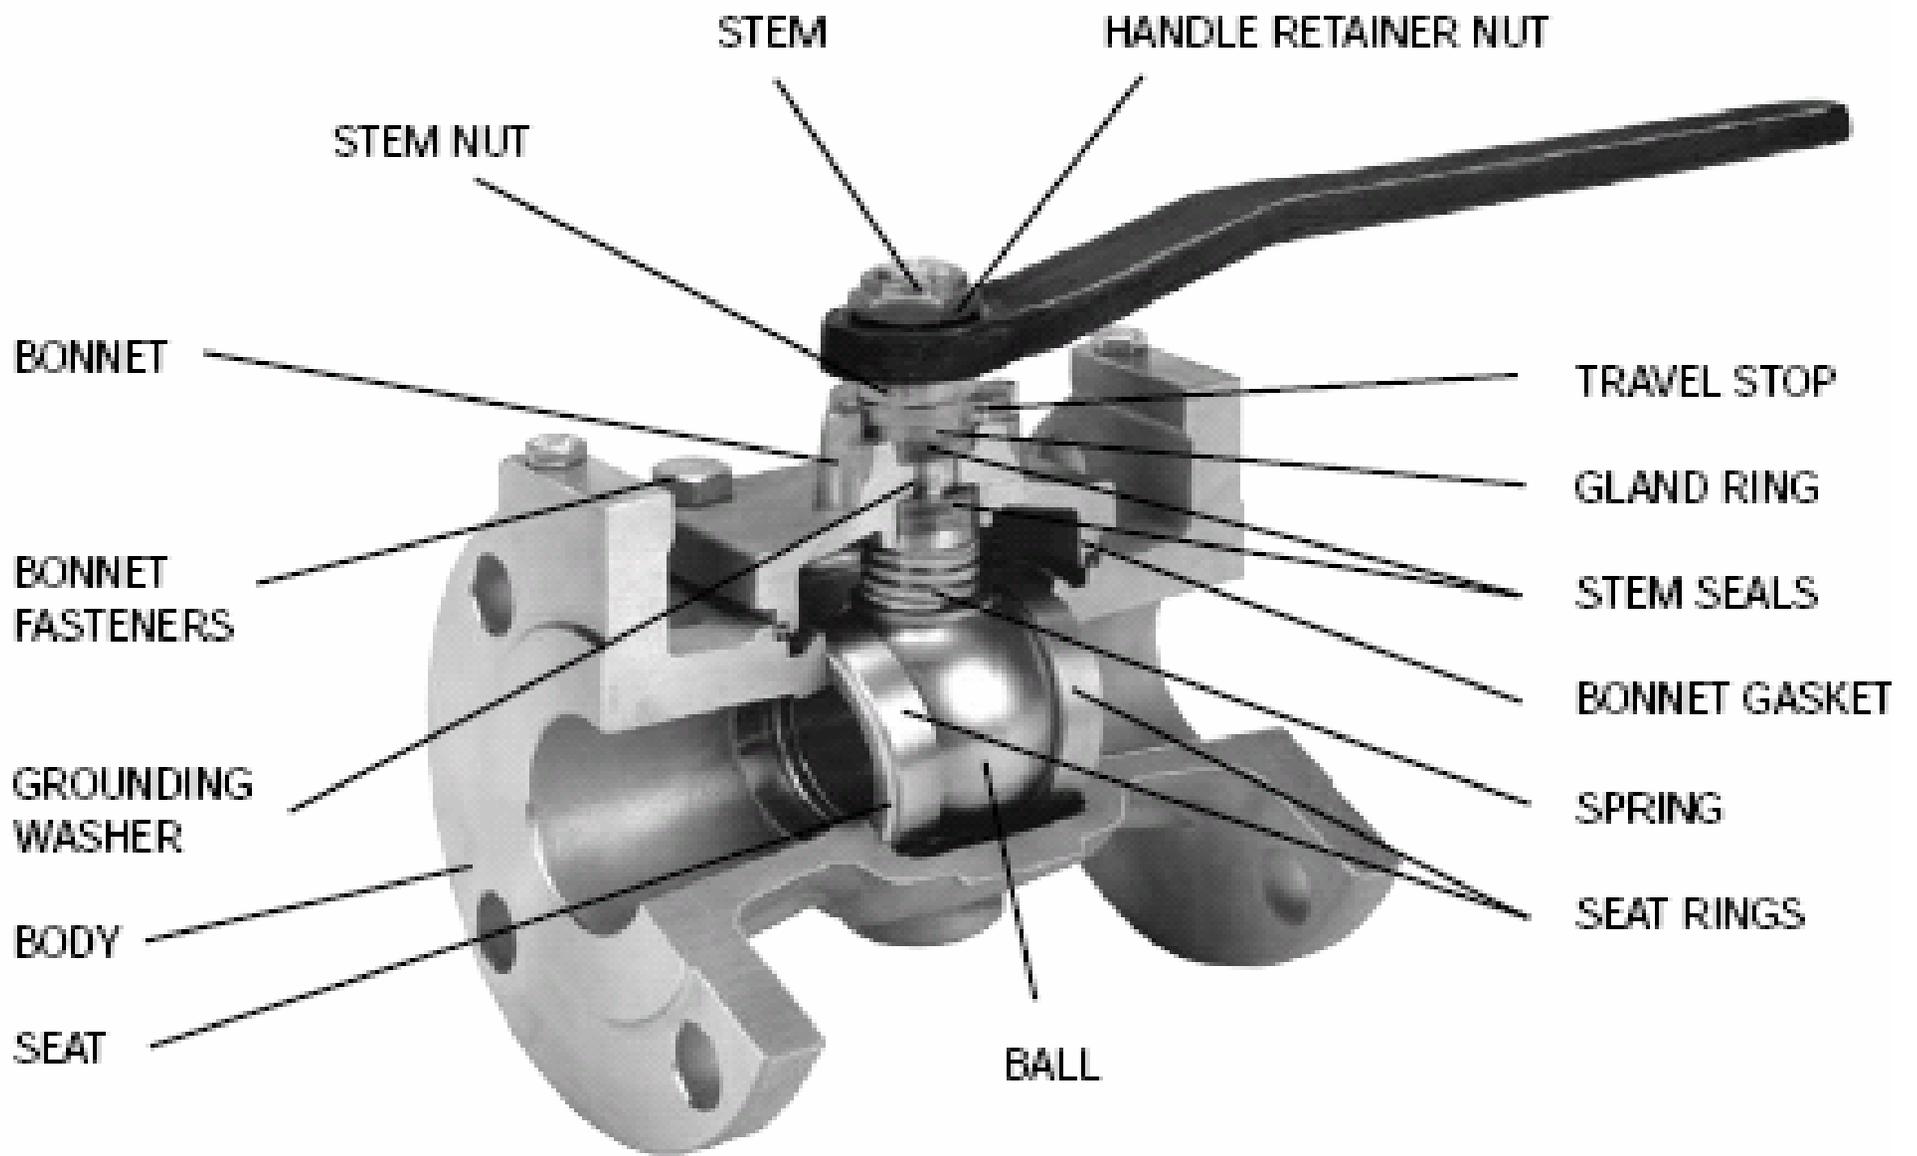
PRESTAGING & PREFAB

- New valve kits including bonnets, stems, seats, and packing were procured
 - The valve kits were preassembled in a clean shop
-

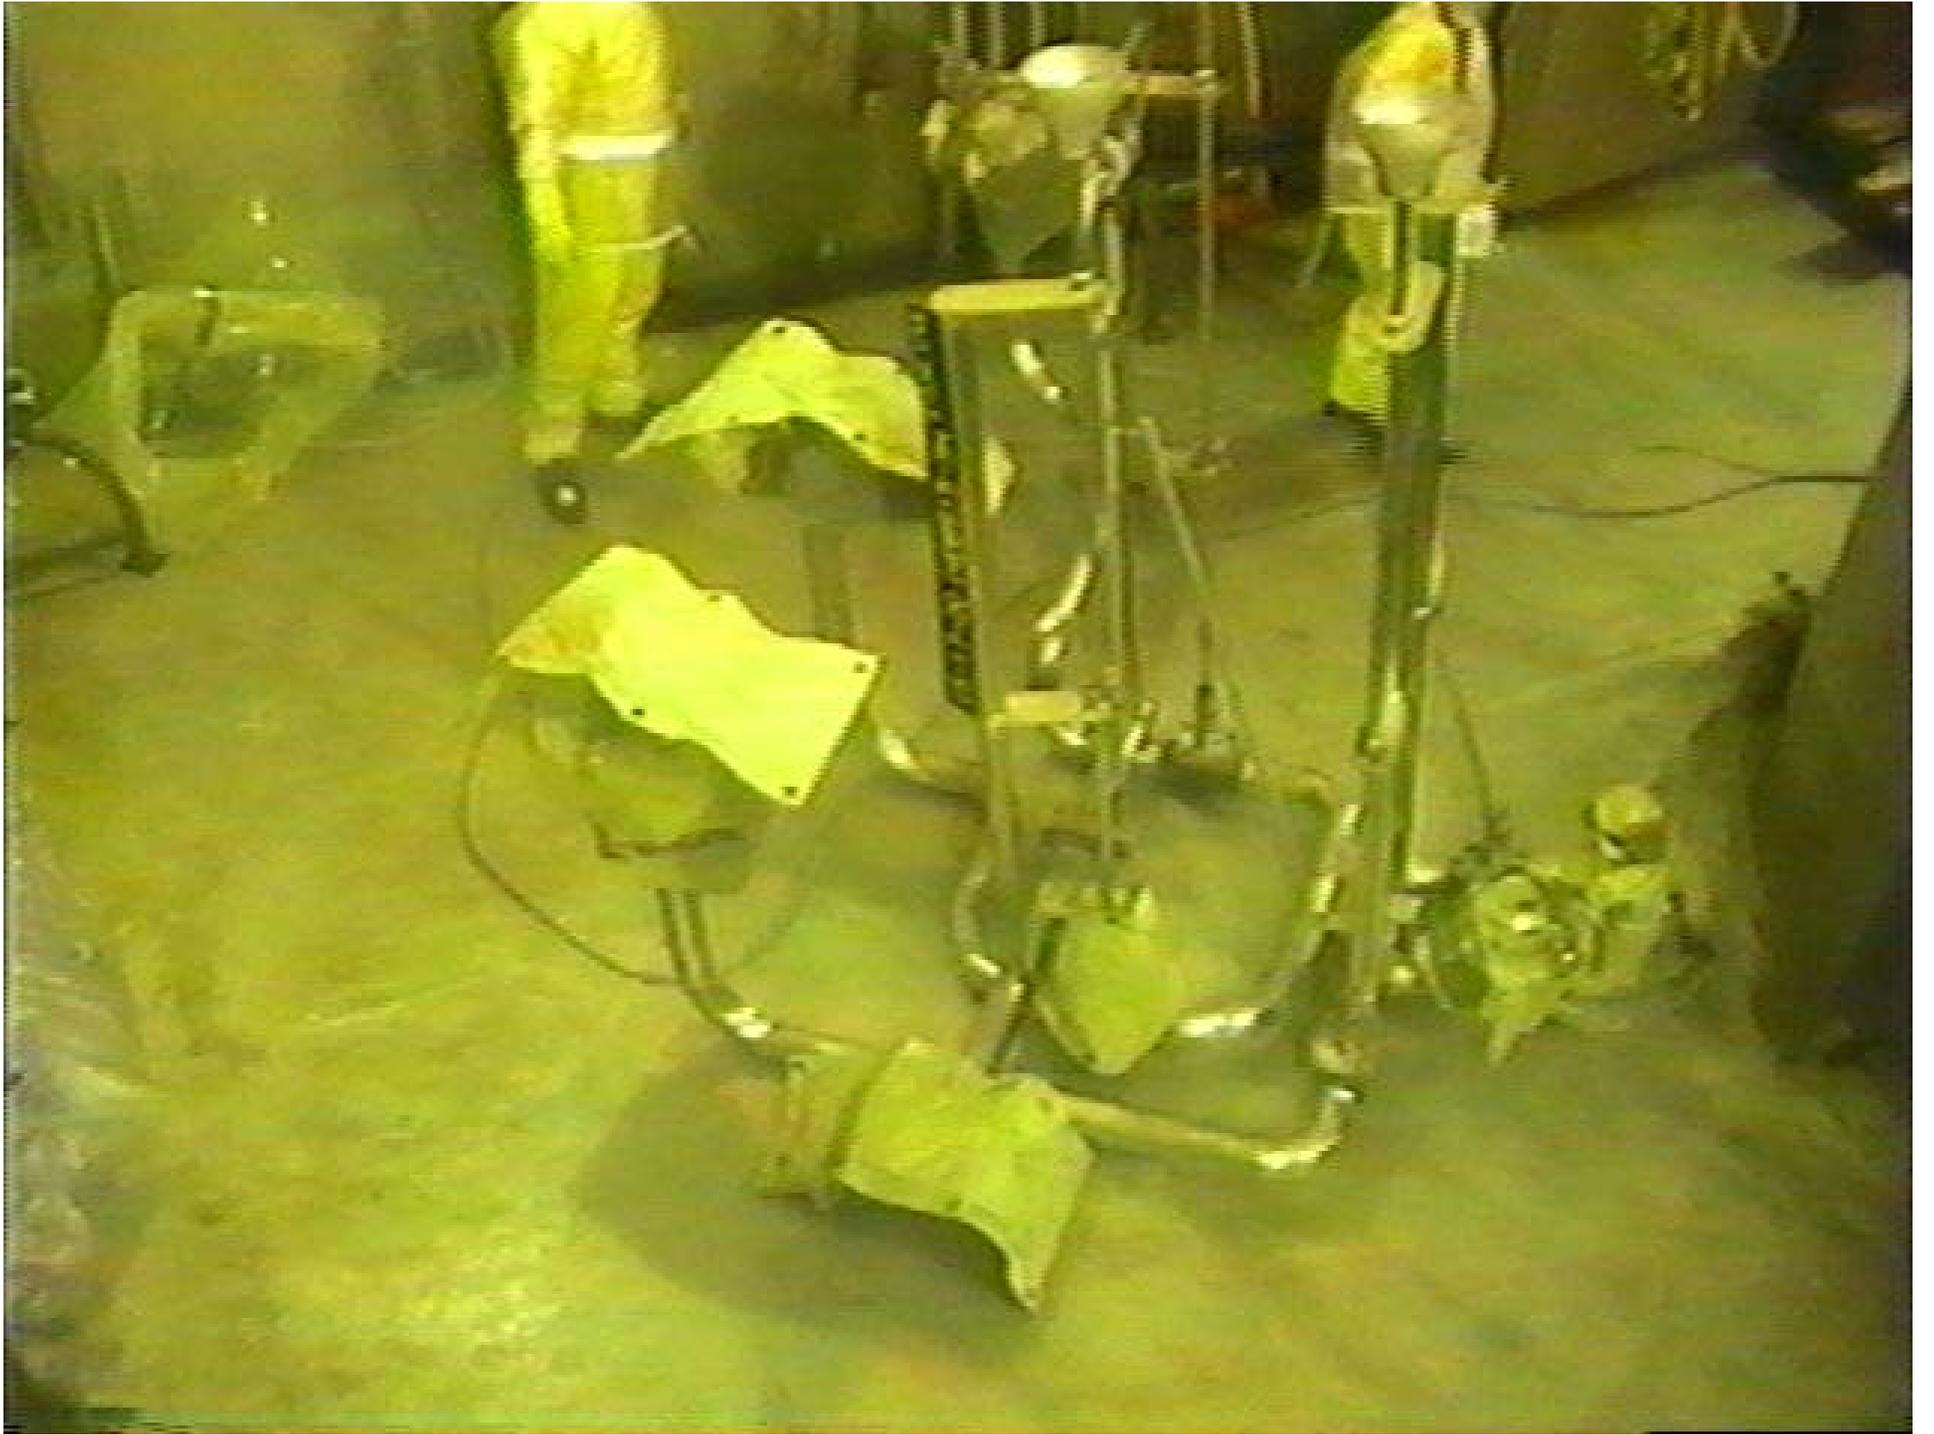
Shielding

- Lead blankets were placed on each connector nozzle and each valve and were moved only for access
-

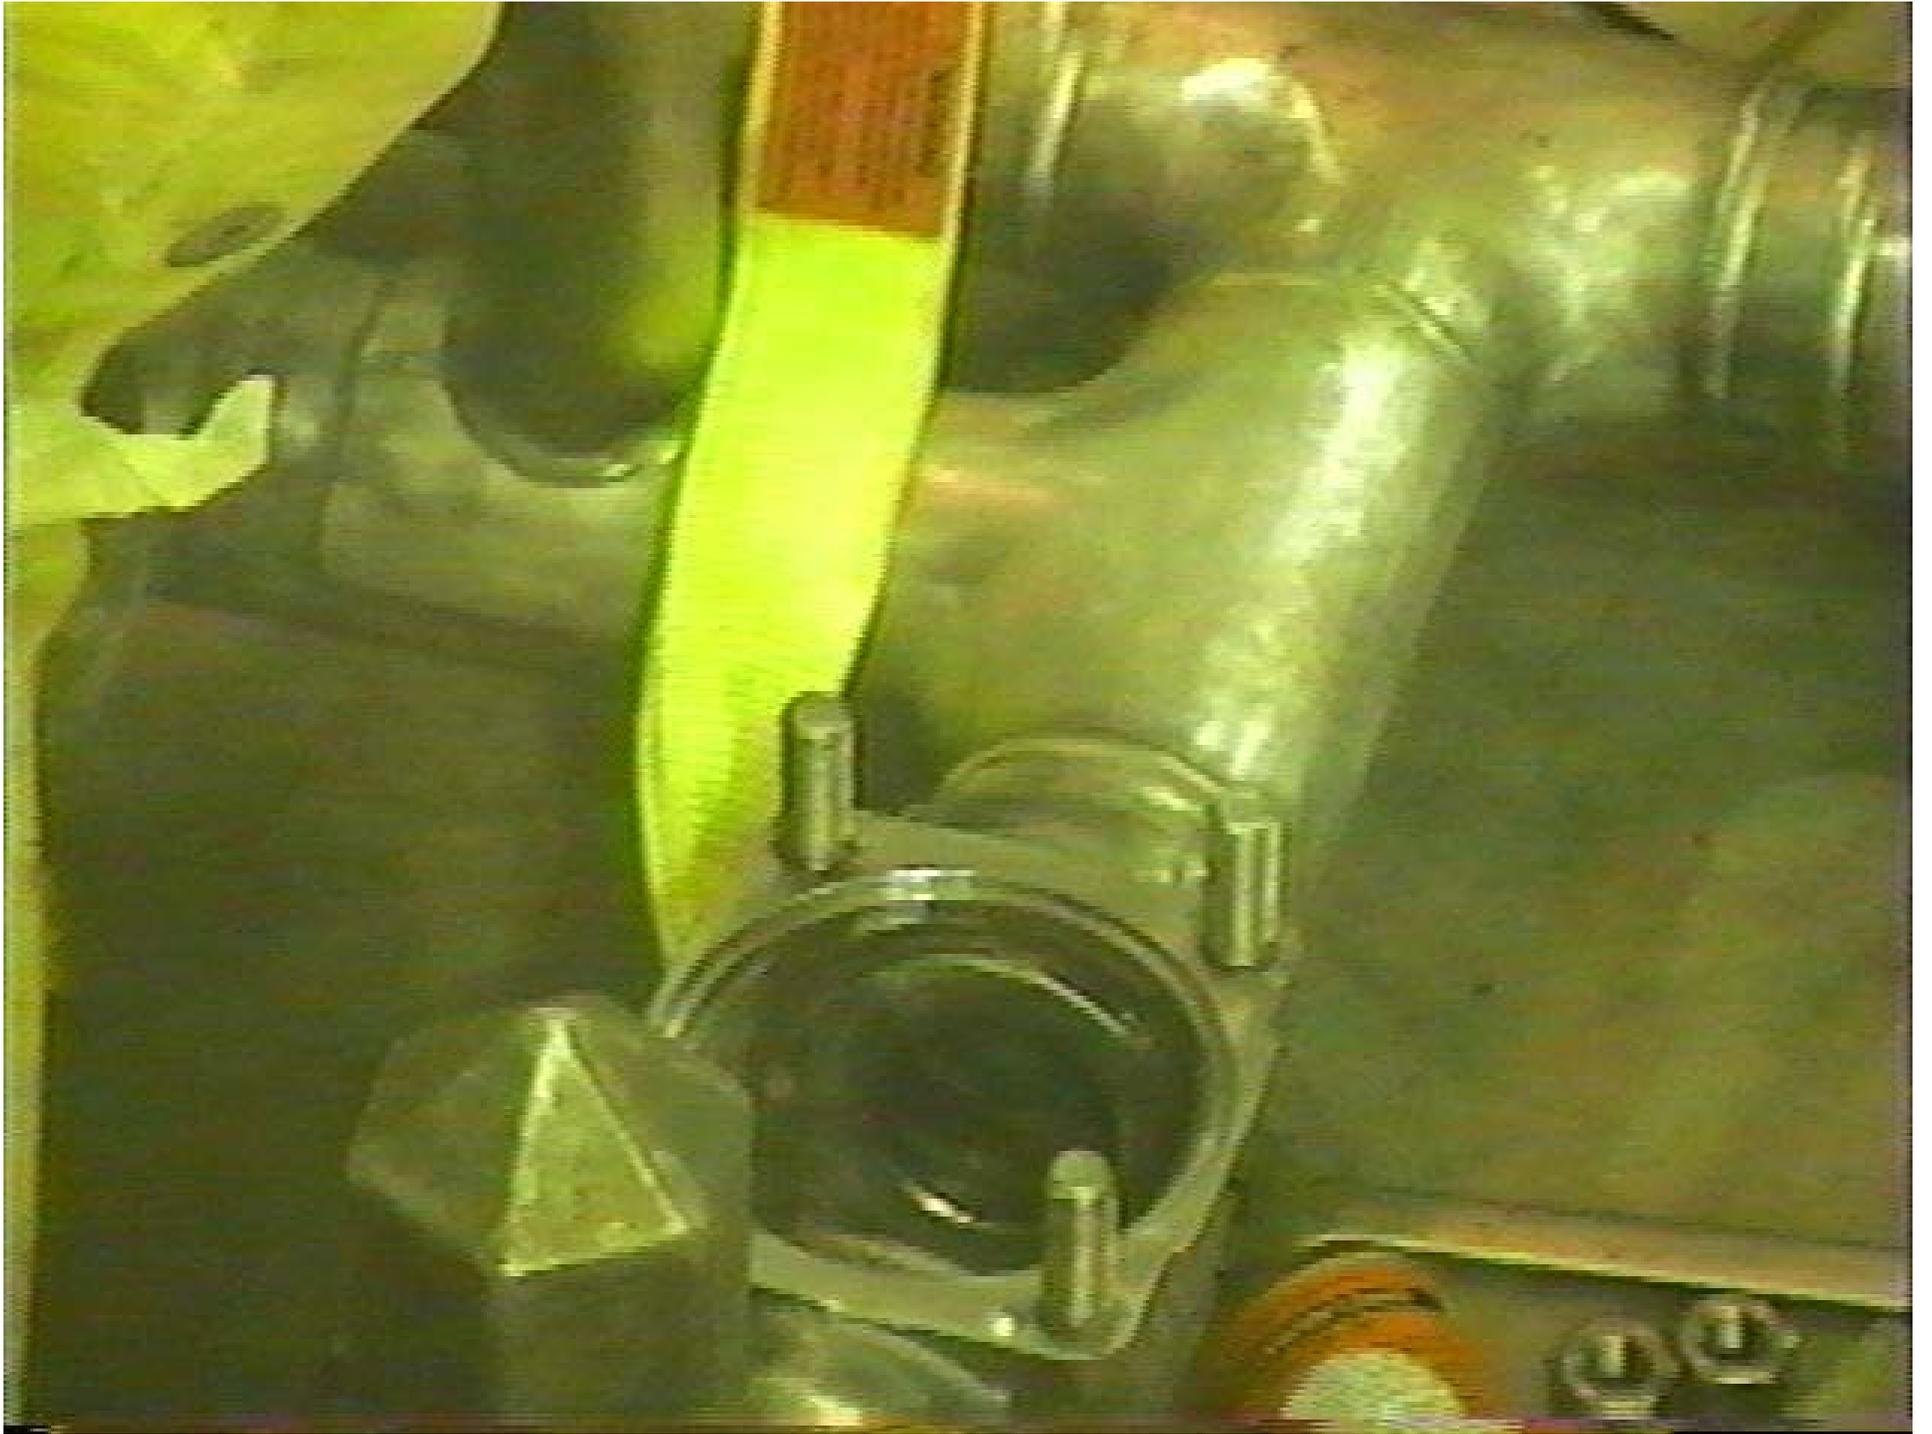
Good Radiological Work Practices

- Mechanics and Radcon moved to low dose area when not working on Jumper
 - Q.A. and welding inspections were performed from a clean area using the remote camera
-
