# *Introduction to Hanford Tanks: Structures, Materials, and Degradation Mechanisms*

Kayle D. Boomer

Washington River  
Protection Solutions

August 25, 2009

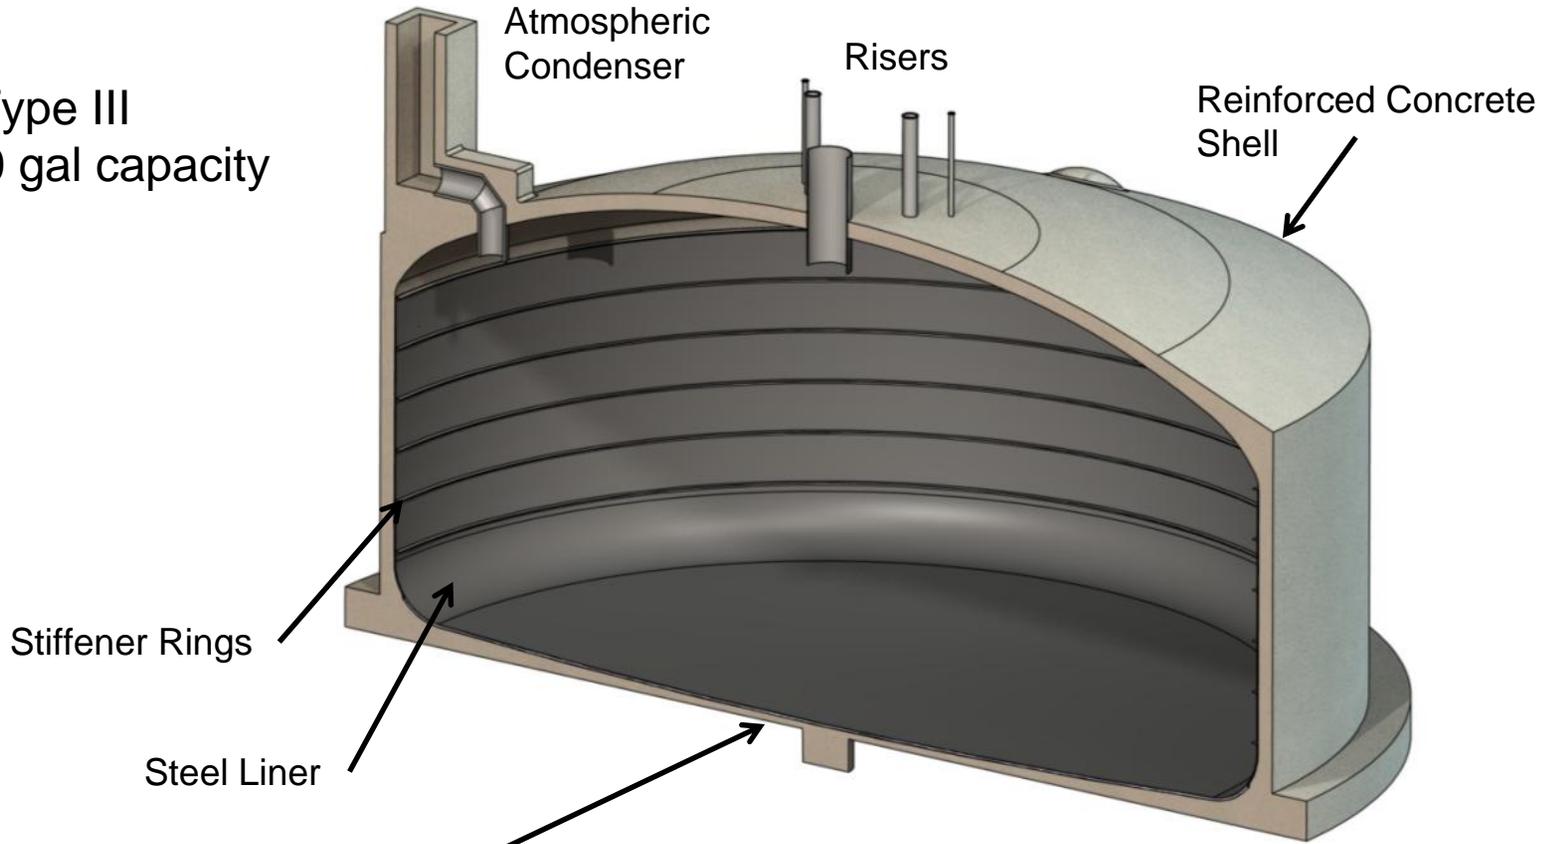
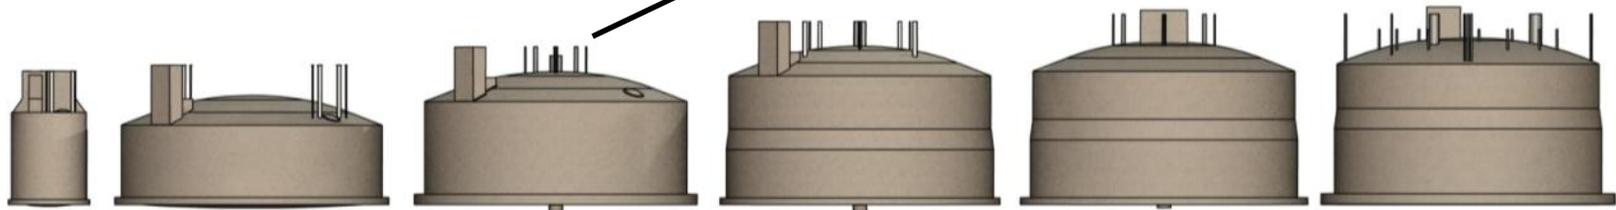
# Single-Shell Tank Description

Type III  
758,000 gal capacity

Type I

Type II

Type III

Type IV A

Type IV B

Type IV C

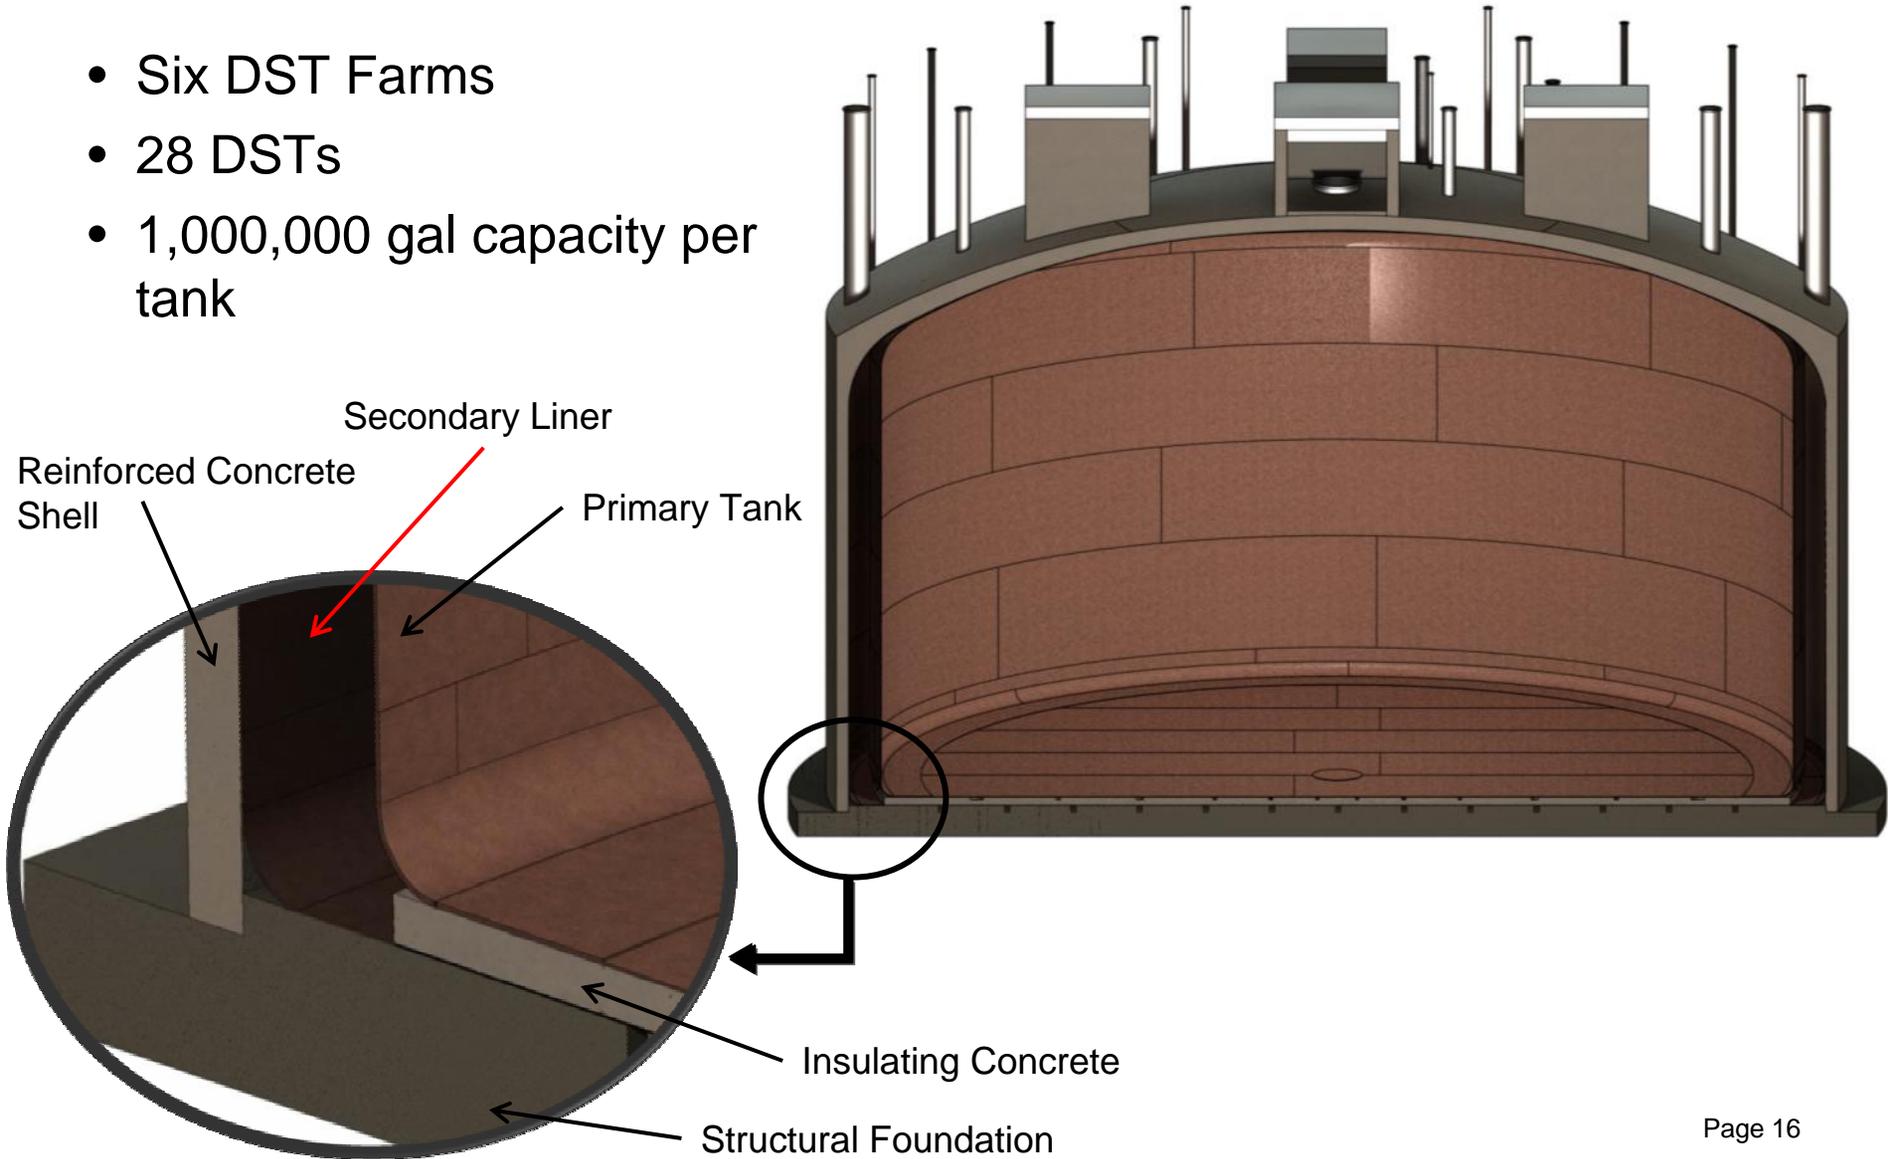
# Double-Shell Tank Description

- Six DST Farms
- 28 DSTs
- 1,000,000 gal capacity per tank
