# Z Area Salt Disposal Facility Update

## Presentation to the Citizens Advisory Board

September 23, 2014

SRR-SSF-2014-00007

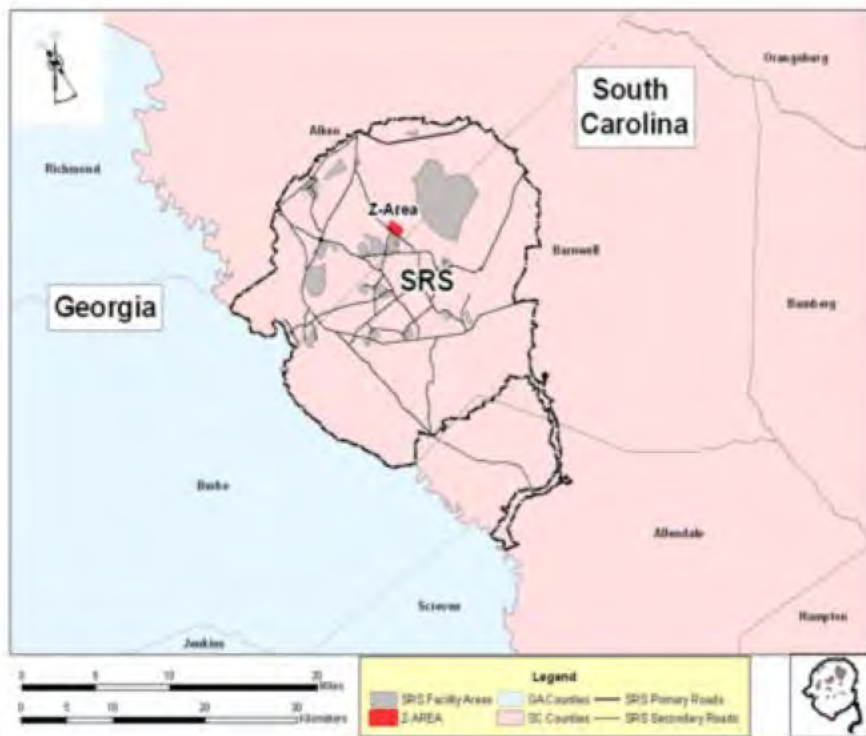
Location of Saltstone Disposal Facility at SRS

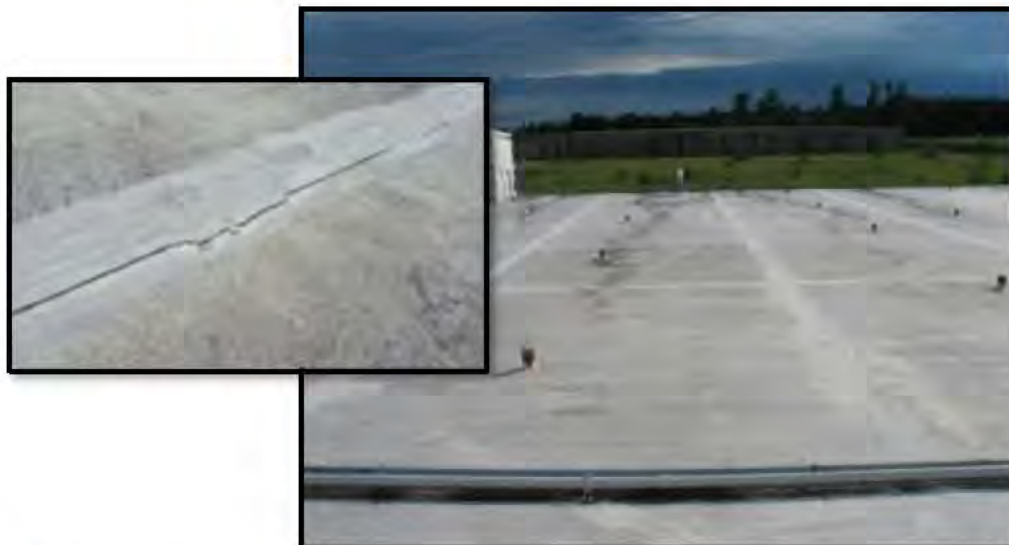
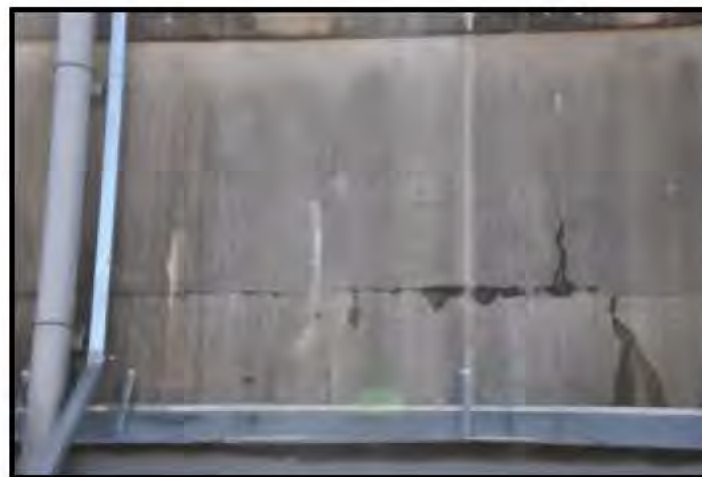
## Vault 4 Water Intrusion

- Cracks in Vault 4 roof allowed rainwater to migrate into the vault
- Liquid collected in the narrow annular space between the grout waste form and the vault wall
- Contaminated liquid could weep through construction joints or cracks that existed in the vault wall

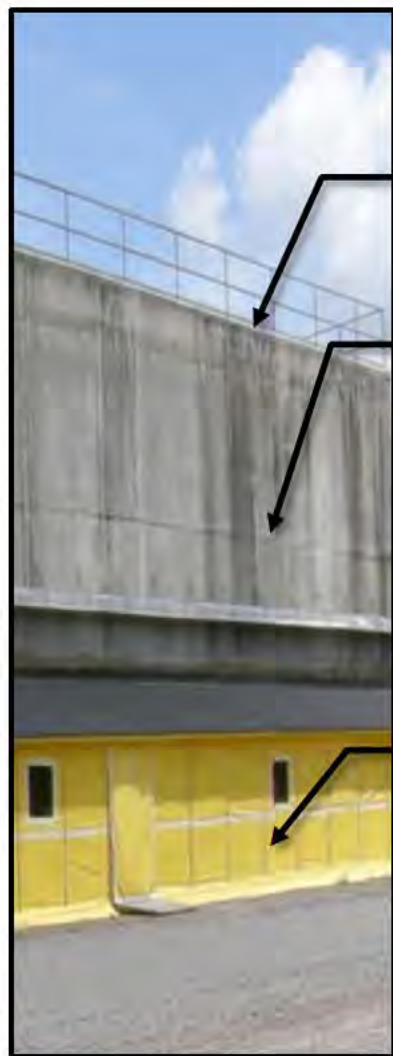
- **Prevent Rainwater Intrusion into Vault (Roof Coatings, Sealants)**
- **Control Rainwater Flow Path**
  - Gutters on roof and weather enclosures
  - Grading to route rainwater to retention basin
- **Fix Wall Contamination**
- **Manage Drain Water Levels Inside Vault**
  - Drain water return system
  - Manage cell water level below hut level to prevent release of contamination to environment
- **Containment**
  - Weather enclosures up to 8'
  - Troughs to collect leakage
  - Isolate from rainwater
  - Installed Megamix coating on walls
  - Installed Xypex coating on walls

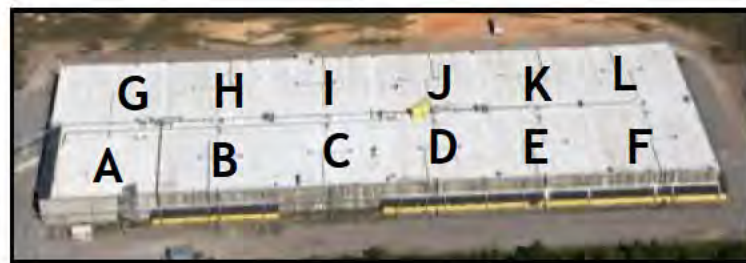
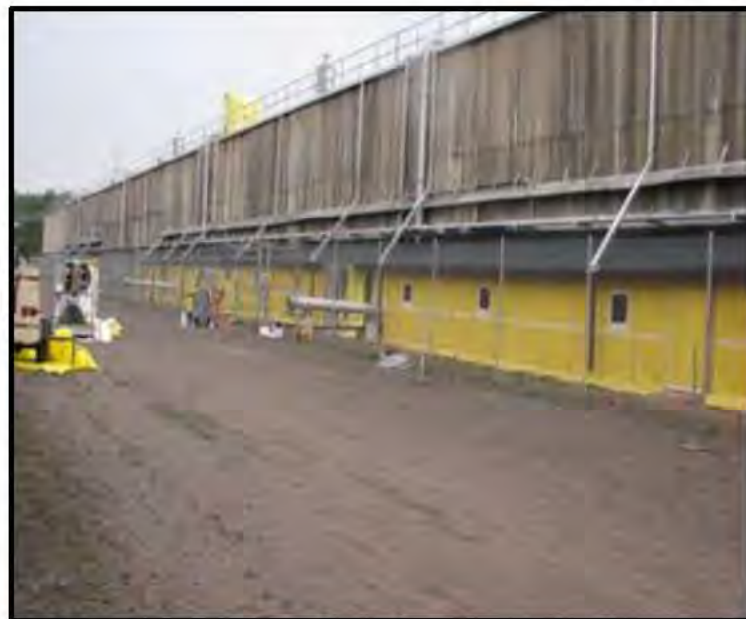
## Vault 4 Stabilization

- **Last Vault 4 disposal operation in 2012**
  - Current disposal operations utilize new design cylindrical SDUs
- **Several alternatives were evaluated to:**
  - Eliminate rainwater infiltration to Vault 4
  - Mitigate worker and environmental risks
- **Alternative selected:**
  - Pour minimum “clean cap” to Vault 4 cells as necessary to establish roof dose rate <5 mrem/hr for worker exposure control
  - Install elastomeric roof covering on cells D, E, F, J, K, and L
    - Cells A, B, C, G, H, and I are already coated/sealed
  - Continue maintenance on roof and weather enclosures
  - Continue to manage drain water levels

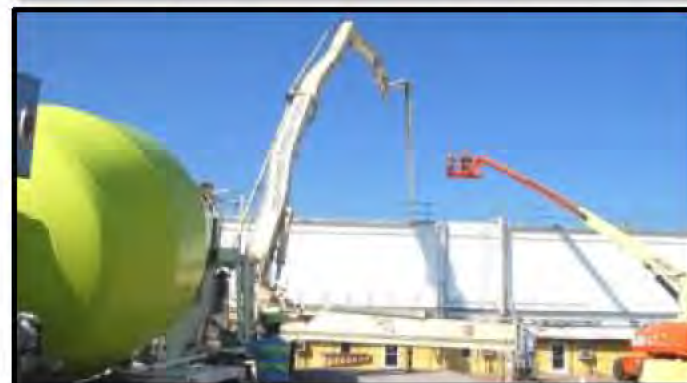
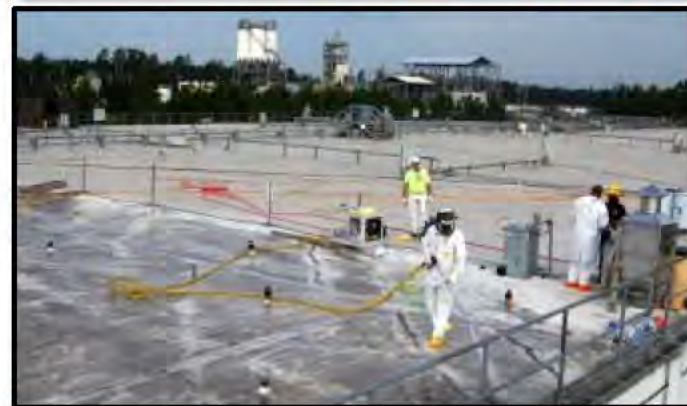
# Vault 4 Stabilization Project Status

- **SRR and DOE are committed to Vault 4 Stabilization Plan**
  - Project fully funded and significantly ahead of schedule
- **Project scheduled to clean cap and apply elastomeric roof coating to three cells in FY14**
  - Clean capping is complete on five cells (J, K, L, D, and E)
  - Roof coating is complete on four cells (J, K, L, and D)
  - Roof coating of cell E in progress
- **Capping and coating of remaining cells planned to complete by February 2015**

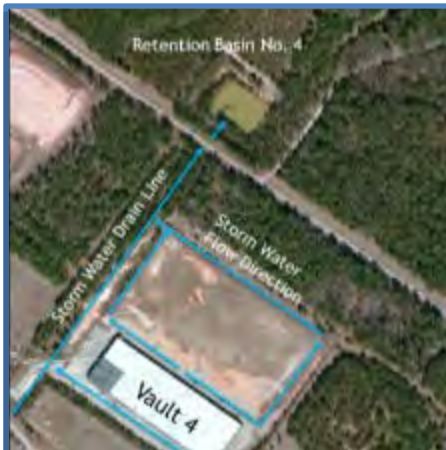
Rainwater carried contamination from Vaults 1 and 4 area to the Storm Water drain line

- Drain line flows to Basin No. 4

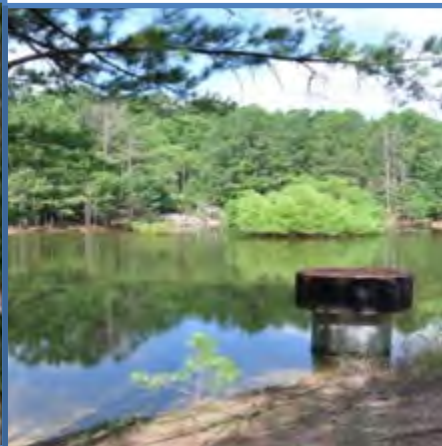
Basin No. 4 only discharges if level reaches the height of spillway

- Feb 2013 first observed basin discharge

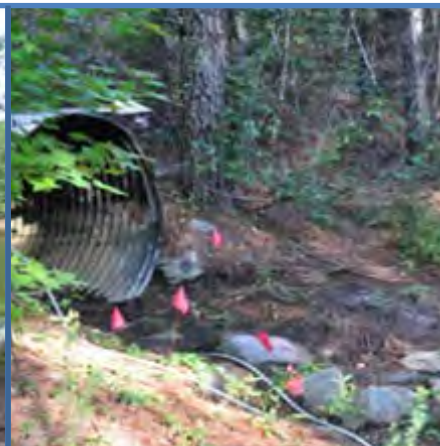
Spillway from Basin No. 4 flows to Storm Water Outfall Z-01

- Low-level contamination deposited

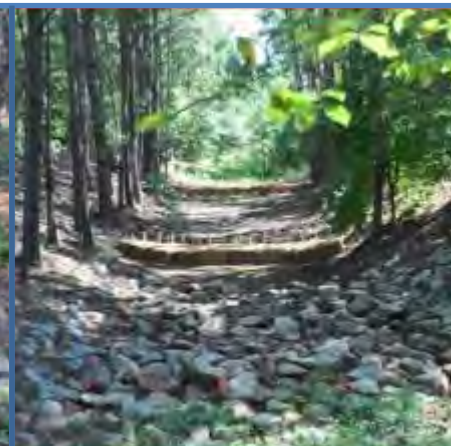
Storm Water Outfall Z-01 flows to McQueen's Branch

- Sedimentation breaks installed to minimize contamination spread

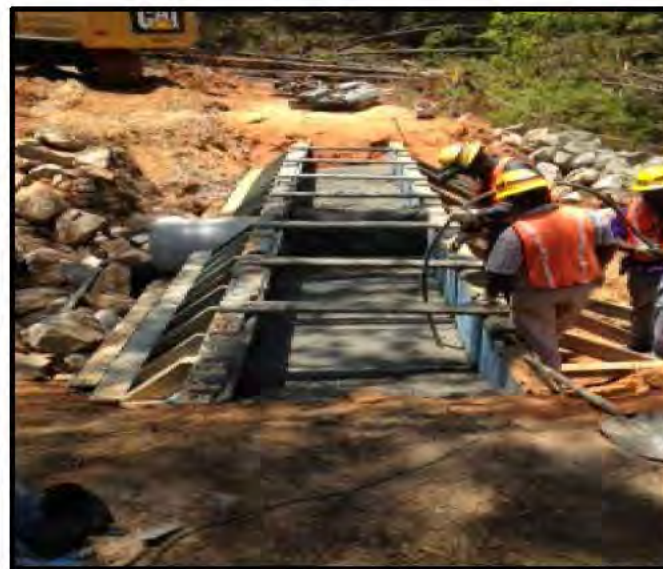
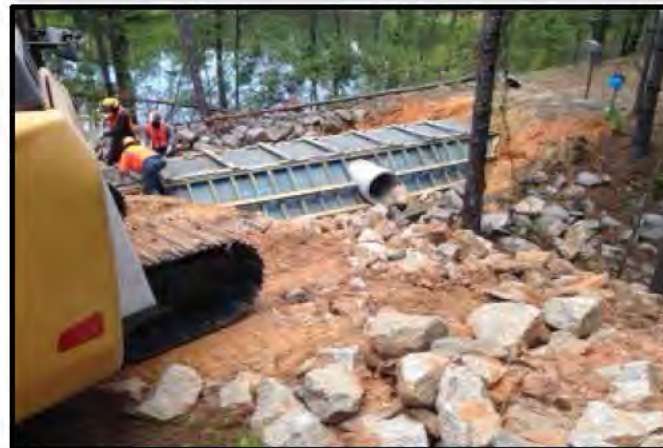
- **Sedimentation basin expanded to 100-year storm event size**
  - Increases volume from 3.3 million to 7.3 million gallons
  - Project completed in September 2014
- **Storm Water Outfall**
  - Completed work to excavate spots of contaminated soil in accordance with DOE Order 458.1 and consistent with the SDF Solid Waste Permit
- **Radioactive effluent monitoring at Outfall and McQueen's Branch continues with no increases detected (sampled when liquid present)**
