Facility Decommissioning Evaluation Building 484-13D, D-Area Storage Building

This is a Simple Model Decommissioning per Facility Disposition Manual 1C

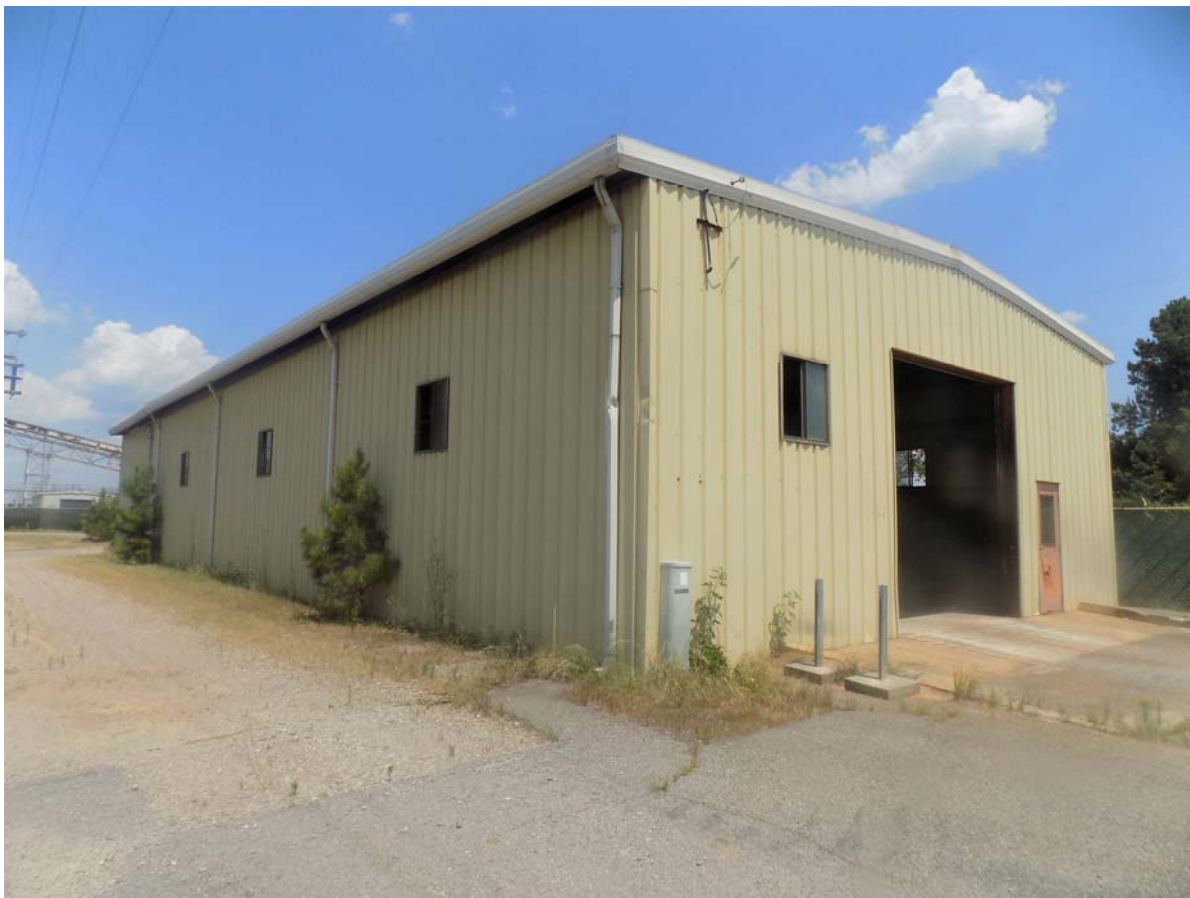
Figure 1. Building 484-13D, D-Area Storage Building and 80-22D, Bone Yard Storage

The Bone Yard Storage, 80-22D (Figures 1, 4, and 5), is enclosed by a fence that surrounds the area. The approximate dimensions of the laydown area are 68 ft by 430 ft. The Bone Yard was used for miscellaneous storage. The Bone Yard appears to have been placed into service after 1973. Buried within the Bone Yard are process lines for domestic water and service raw water.

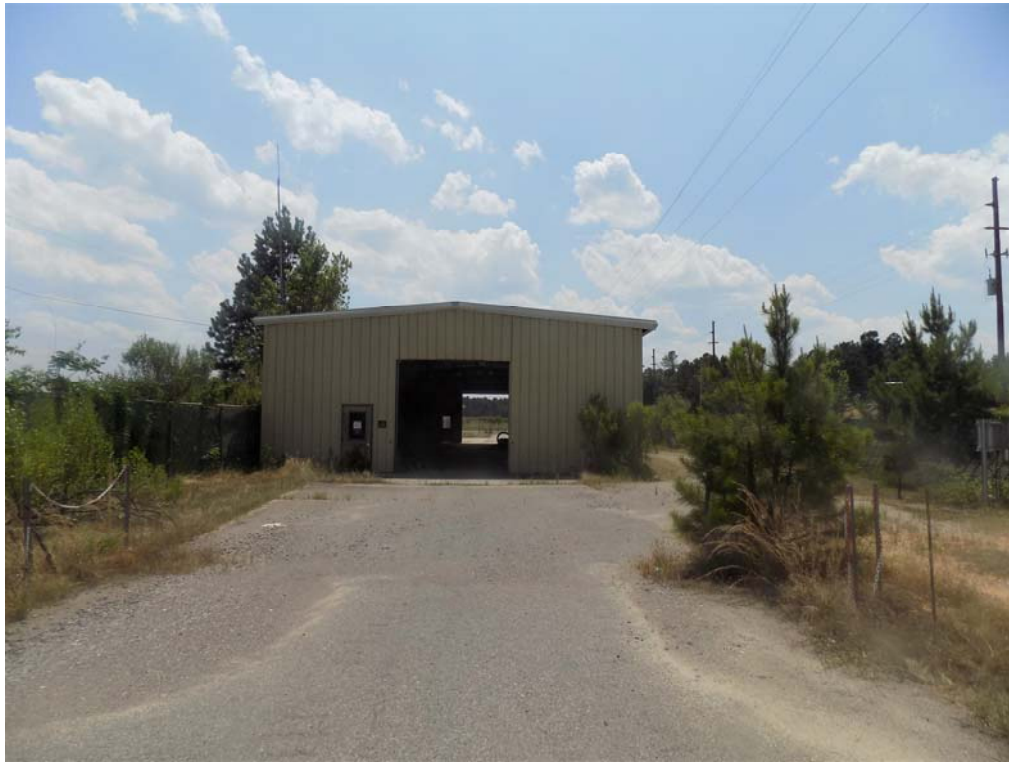
Figure 2. Building 484-13D, D-Area Storage Building

Building 484-13D (see Figures 1, 2 and 3 for photographs and Figures 4 and 5 for layout) is a steel frame structure with a metal skin and roof. The structure is attached to a concrete slab. The structure itself is approximately 96 feet (ft) by 42 ft, with a small partitioned interior space. The interior is partitioned into a large storage area and a smaller partitioned area. The structure does not appear to have any asbestos or lead in the materials. Construction of the structure was completed post-1987.
