# *Hanford In-Service Inspections*

Jason Engeman

Washington River  
Protection Solutions

8/25/2009

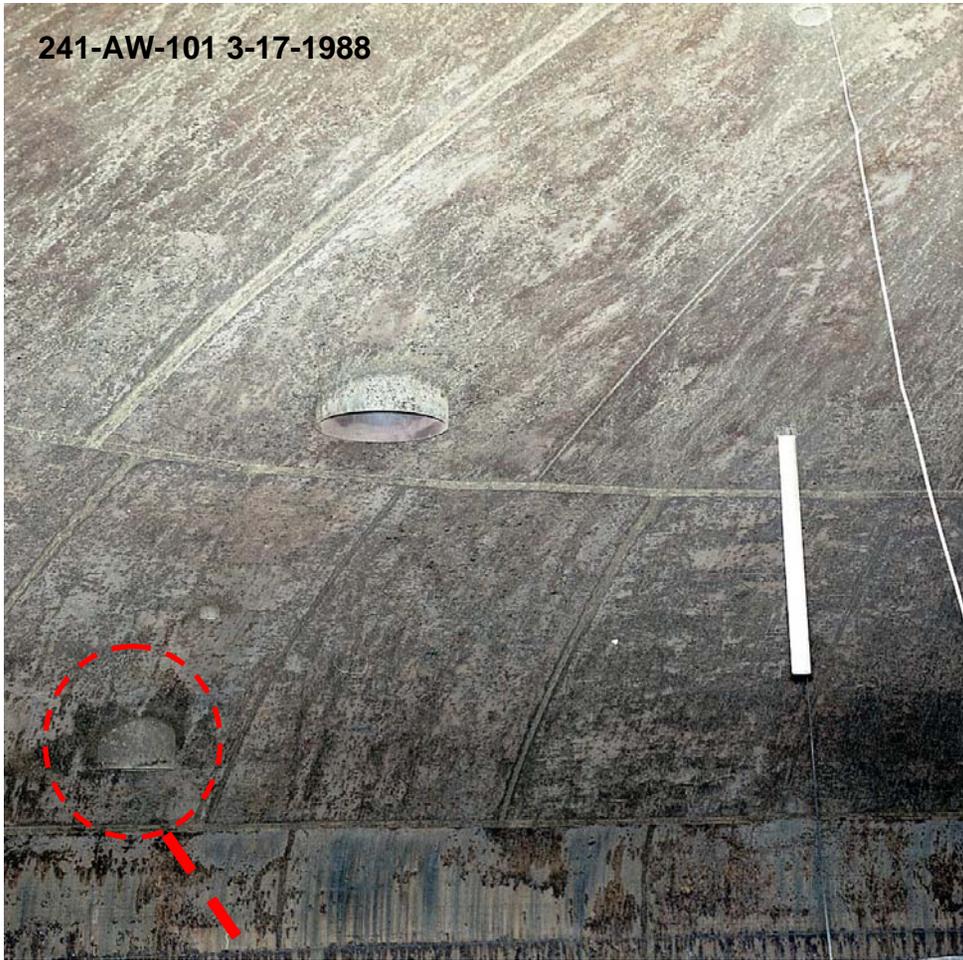
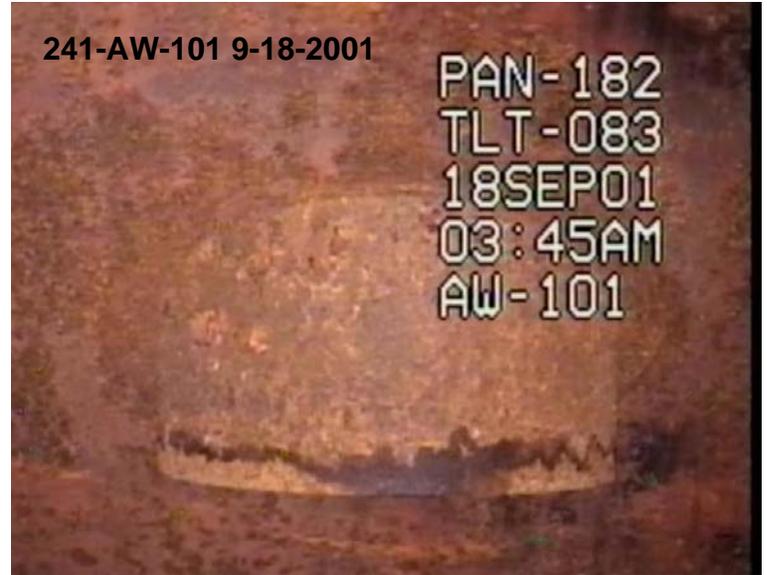
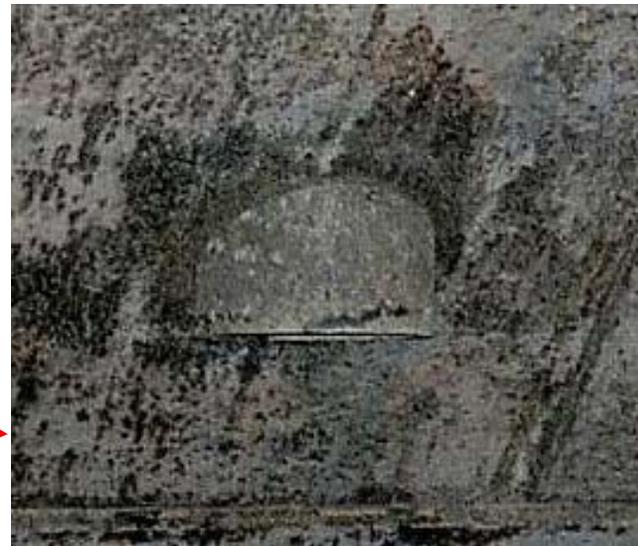
# Annulus Water Intrusion

- Most DST annuli display relatively very light corrosion (Exception: The 241-AY DSTs were subject to heavy corrosion ~10 years ago due to water intrusion into the annulus).
    - Mill scale still present in various tanks.
    - No tanks show signs of active water intrusion into the annulus.
