LUCIP for the Silverton Road Waste Unit (731-3A)

WSRC-RP-97-153, Revision 1.1, March 1998

**Final Remediation Report for the
Silverton Road Waste Unit (731-3A) (U)**

WSRC-RP-97-153

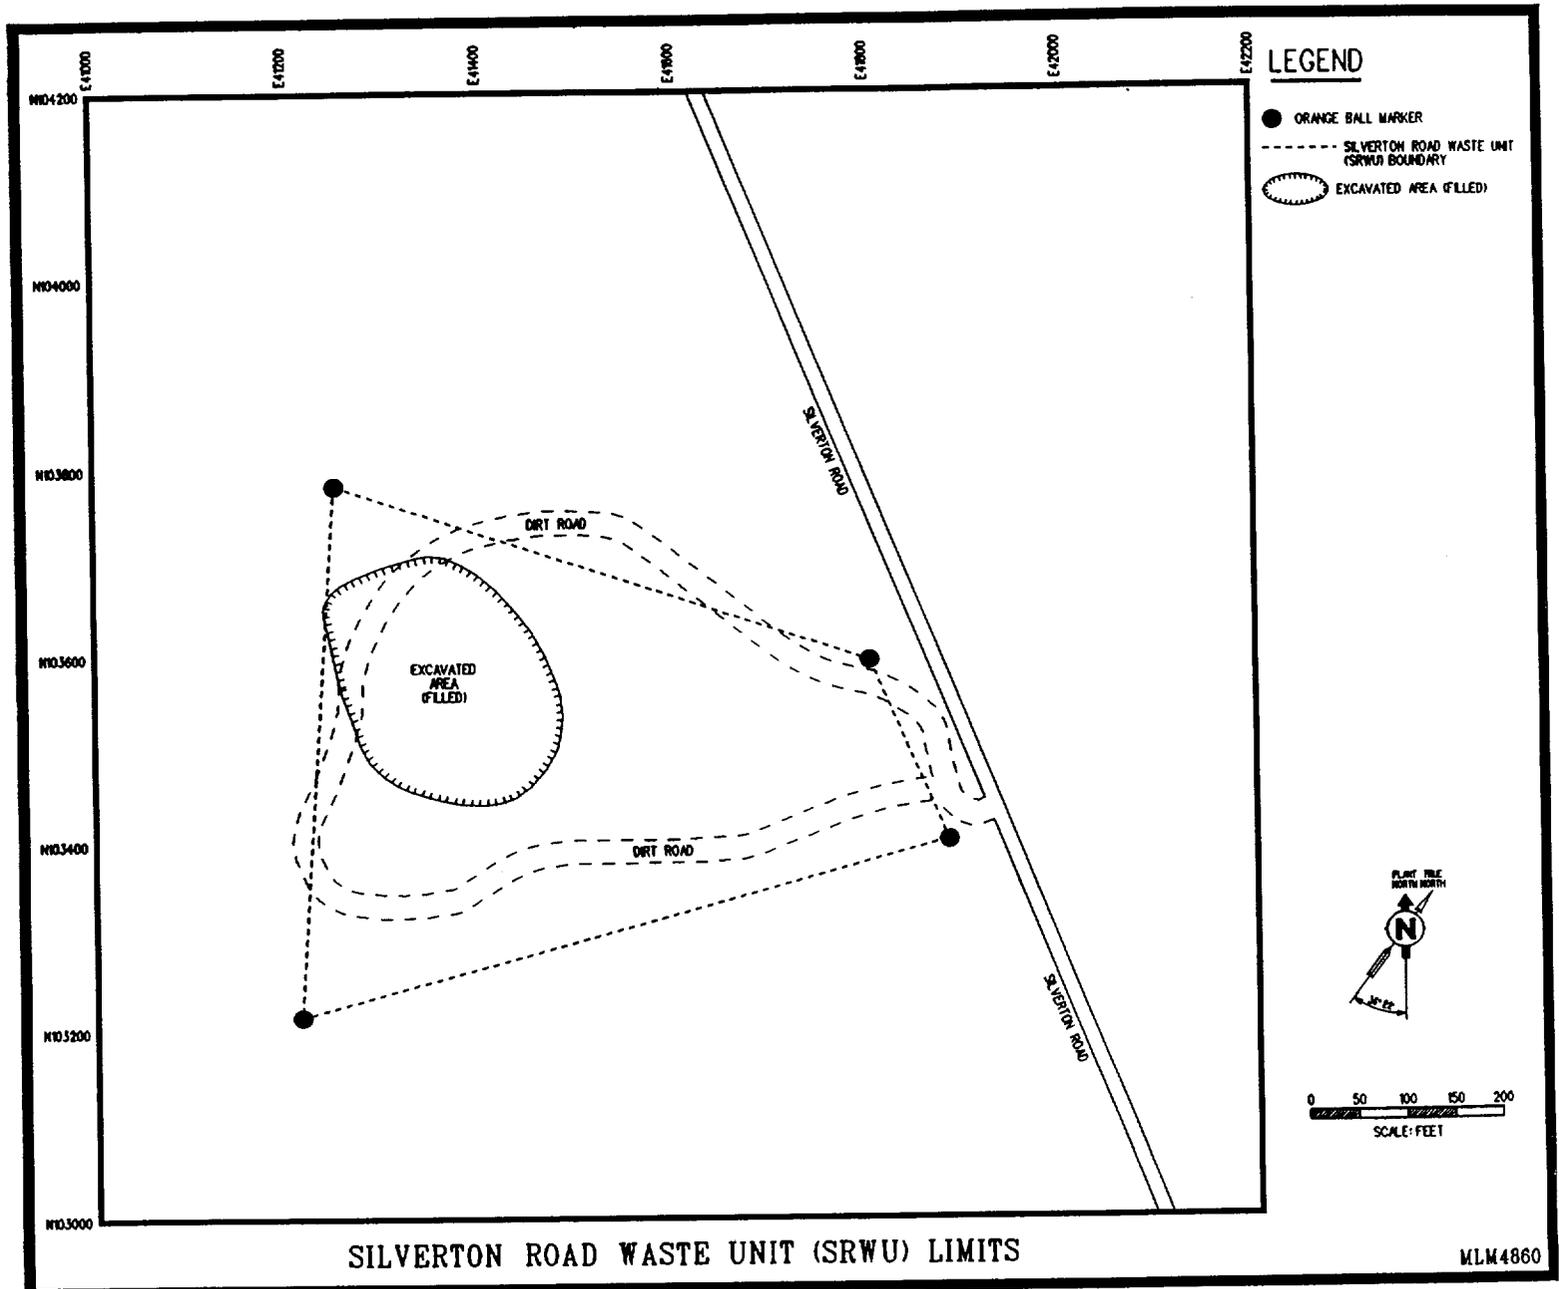
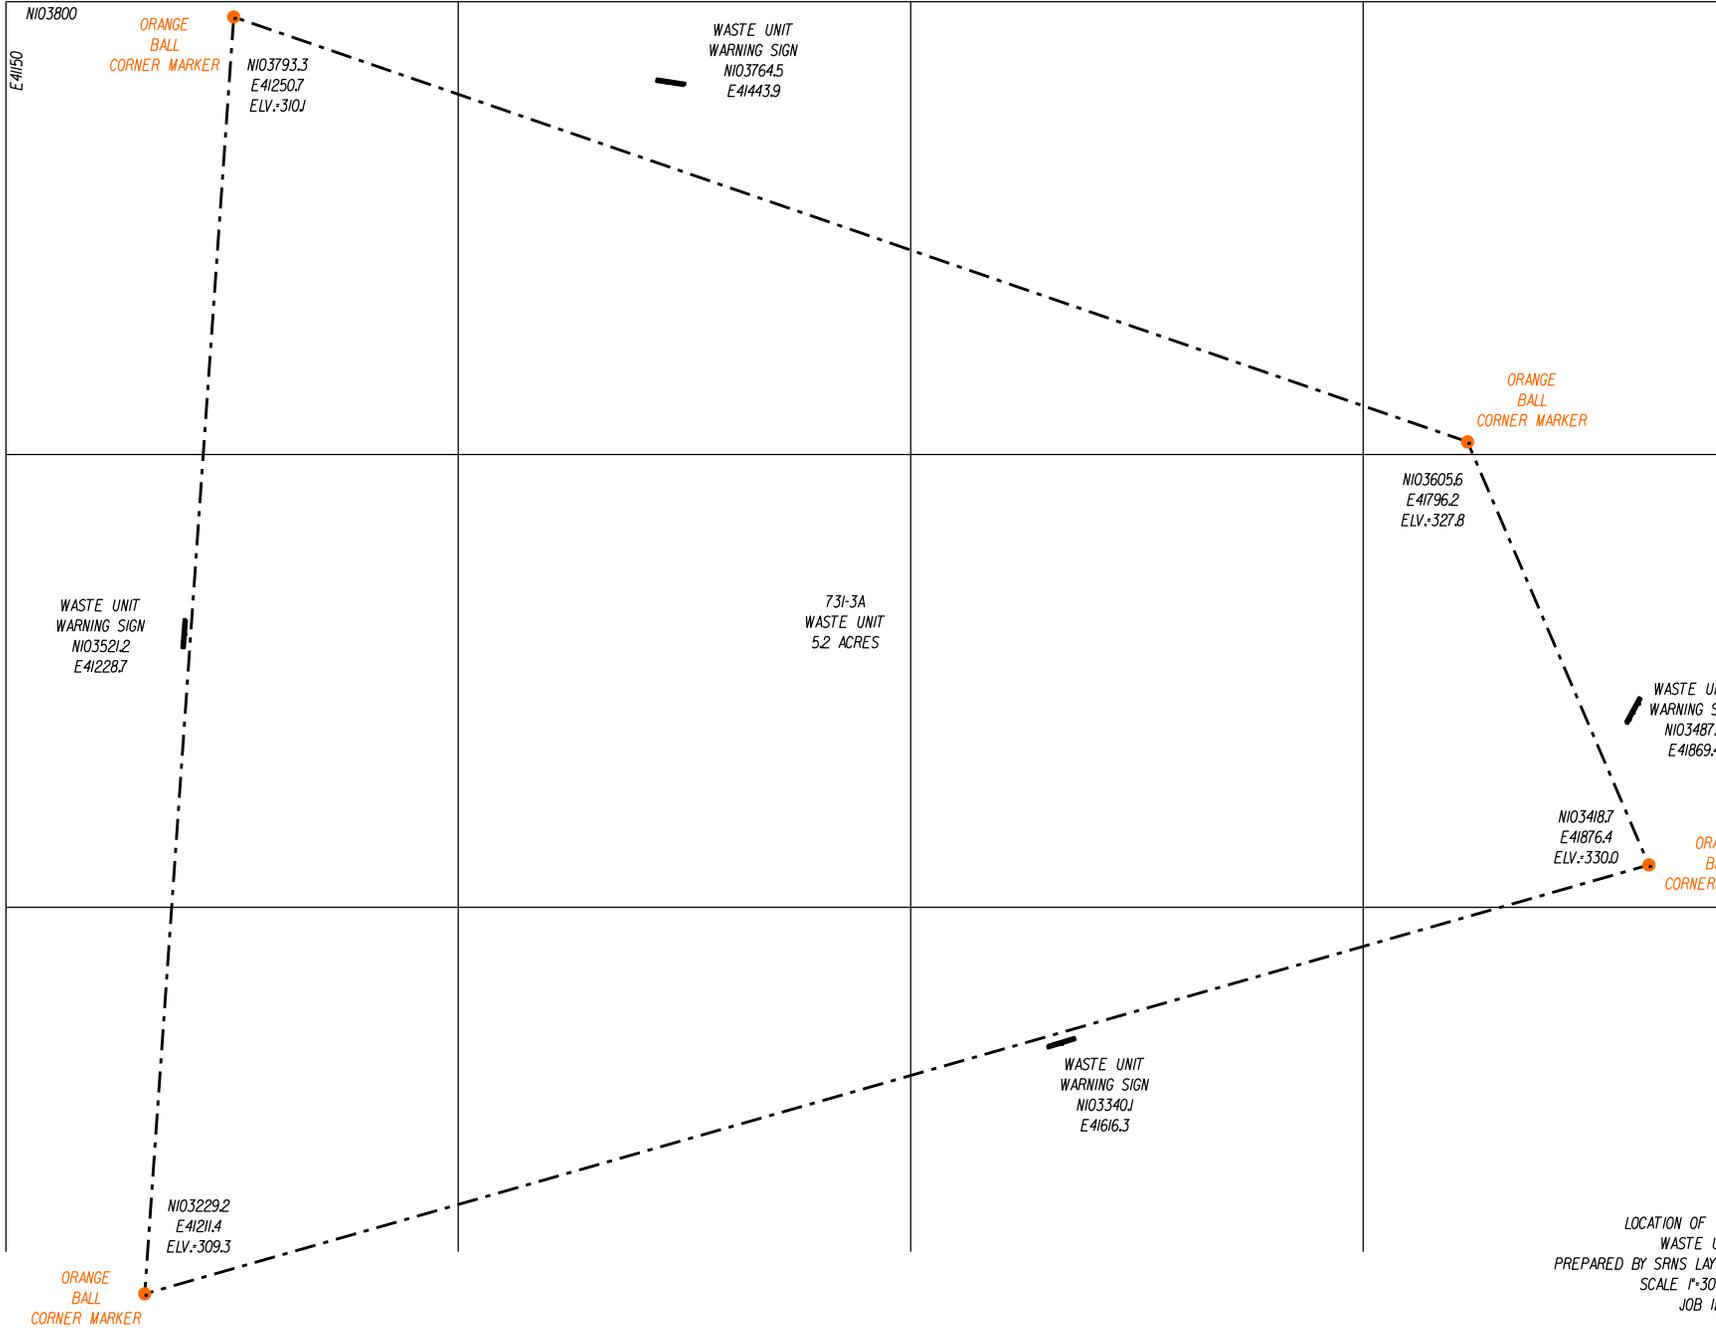
Figure 2. General Configuration of the Silverton Road Waste Unit

WASTE UNIT
WARNING SIGN
N103764.5
E41443.9

ORANGE
BALL
CORNER MARKER

731-3A
WASTE UNIT
5.2 ACRES

The Silverton Road Waste Unit (SRWU), Building 731-3A, comprises a Resource Conservation and Recovery Act (RCRA)/Comprehensive Environmental Response, Compensation, and Liability Act (CERCLA) waste unit and is located in the northwestern part of the Savannah River Site (SRS) in Aiken County (Figure 1), approximately 1.5 miles southwest of A/M Area. The SRWU area is an irregular quadrilateral, unlined earthen depression dug into surficial soils that was later filled with various waste materials. This area has been designated as an "excavated area (filled)" as depicted in Figure 2.
